NDT Inspection
<https://tuboafrika.nov.com/>

Client
Suez Canal Container Terminal

RTG Crane
CR 16

Summary of Inspection

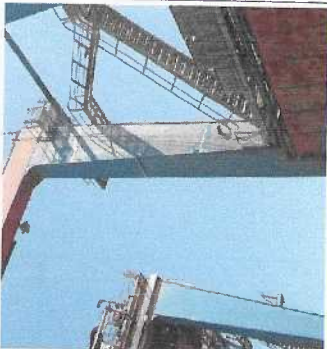
RIGHT LEG OF ELECTRIC HOUSE SIDE (FRONT)						
1

#	DATE	DRAW NO. :	Exact location	Defect description	Inspector	Pic. of defect
0	22/09/2017	DRAW NO. JL1190301A	NO-1 RIGHT LEG OF ELECTRIC HOUSE SIDE (FRONT)	2 EA CRACKS MIN 3 cm	M. Asaad

During inspection found cracks in 10 areas, mentioned in our defect report. Any cracks shall be unacceptable, regardless of size or location as per AWS D1.1. These cracks shall be repaired before putting crane back into service using manufacture's repair procedure/recommendation.

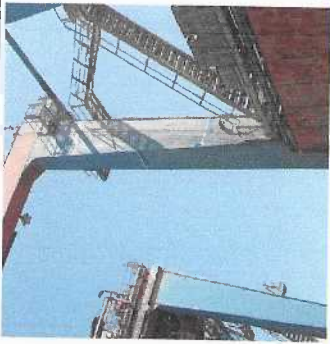
DRAW NO. JL1190301A			
			RIGHT LEG OF ELECTRIC HOUSE SIDE (REAR)		
1			No:1 R.E.R CRACK 6CM

No:2 R.E.R CRACK 4CM

No:3 R.E.R CRACK 5CM

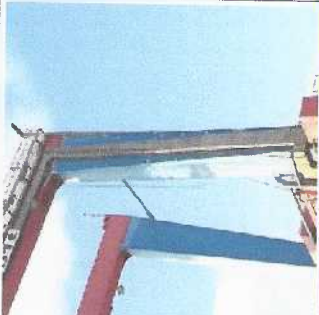
RIGHT LEG OF DIESEL HOUSE SIDE (IN SIDE)							
1

#	DATE	T.V. Work Order No. : Customer :	SD-119039 SUZUKI CANAL CONTAINER TERMINAL	Customer W.O. No. Work location	Inspector	Defect description	Pic. of defect
0	23/09/2017	DRAW NO. : DRAW NO. JL1190301A	NO-2 RIGHT LEG OF DIESEL HOUSE SIDE (IN SIDE & RAER)		M. Asaad	03 EA CRACKS MIN 2 cm & MIX 4cm

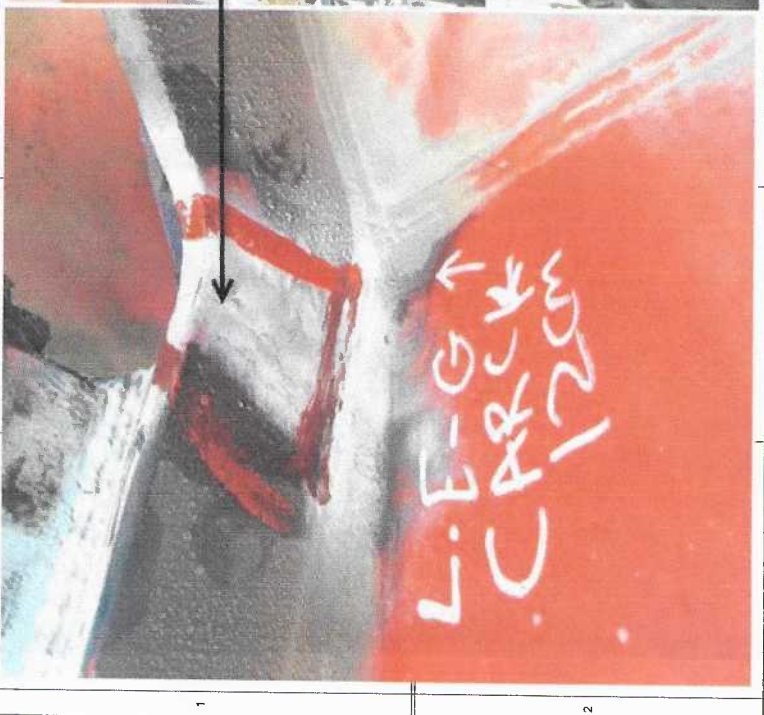
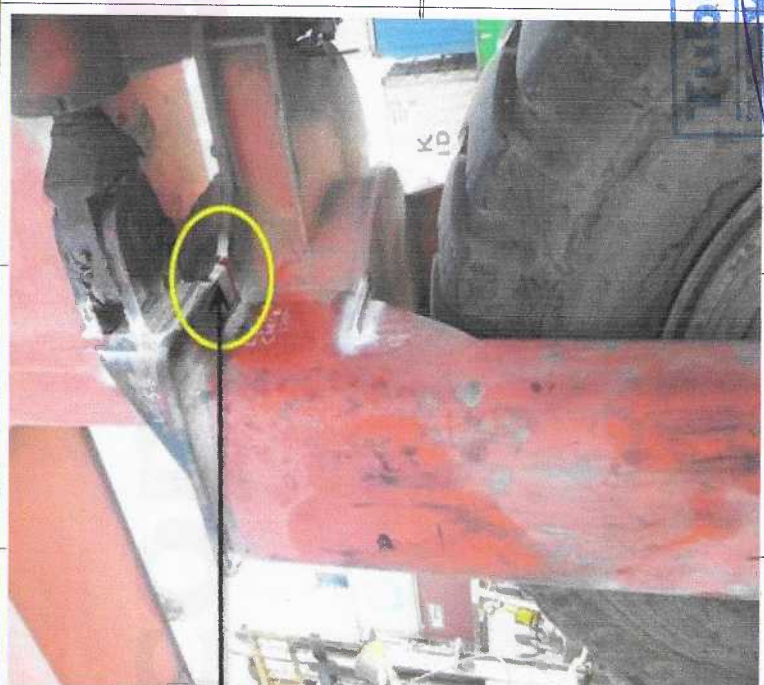
#	DATE	DRAW NO. :	Exact location	Defect description	Inspector	Pic. of defect
0	25/09/2017	DRAW NO-JL11901-1	LEFT ELECTRIC HOUSE SIDE CENTRY TRAVELING MECHANISM - Idel carriage JL-1190106	1 EA CRACK 12 CM	M. Asaad	
LEFT ELECTRIC HOUSE SIDE CENTRY TRAVELING MECHANISM - Idel carriage JL-1190106						
1

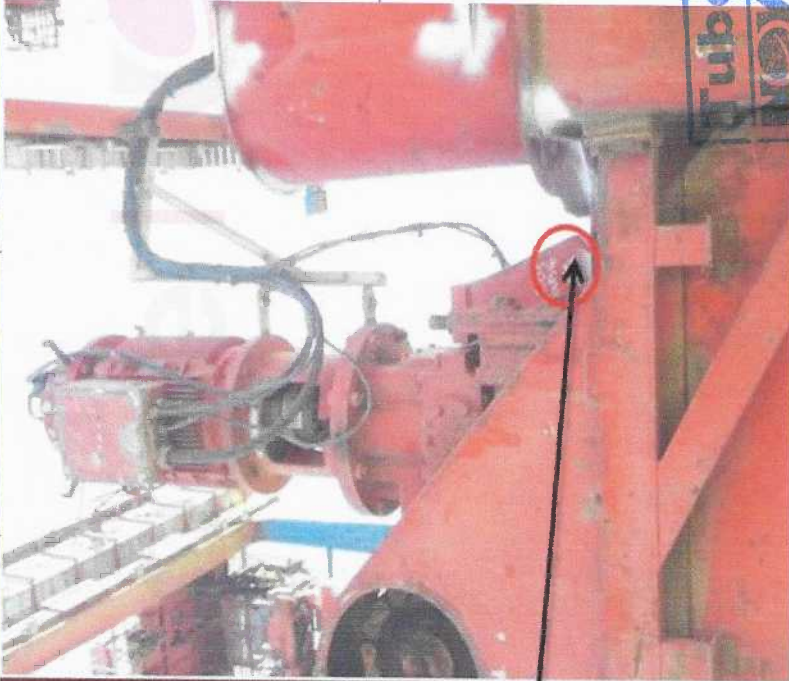
#	DATE	DRAW NO. :	Exact location	Defect description	Inspector	Pic. of defect
0	25/09/2017	DRAW NO. JL11901B	RIGHT DIESEL HOUSE SIDE MOTOR SUPPORT B6 (OUTER)	1 EA CRACK 4 cm	M. Asaad	
RIGHT DIESEL MOTOR SUPPORT B6 (OUTER)						
1

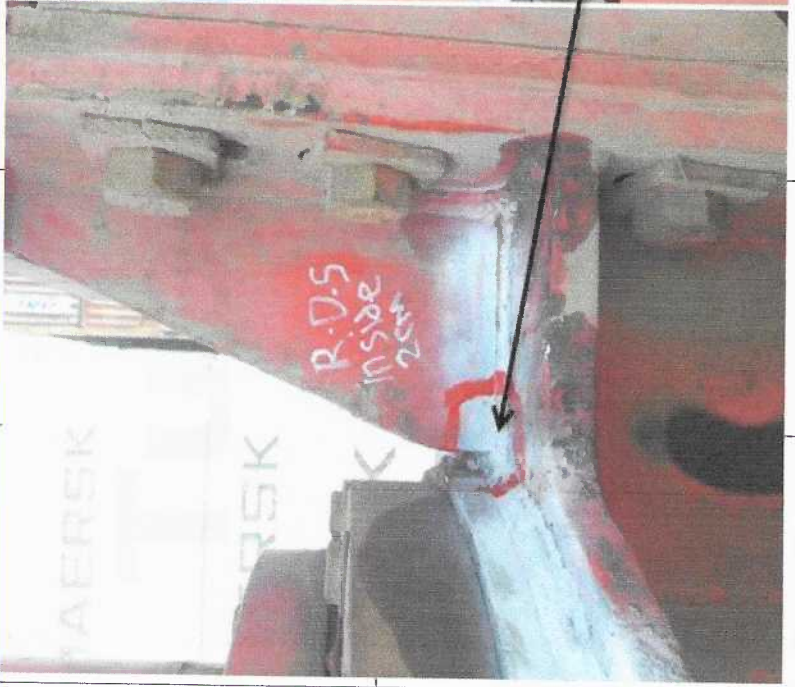
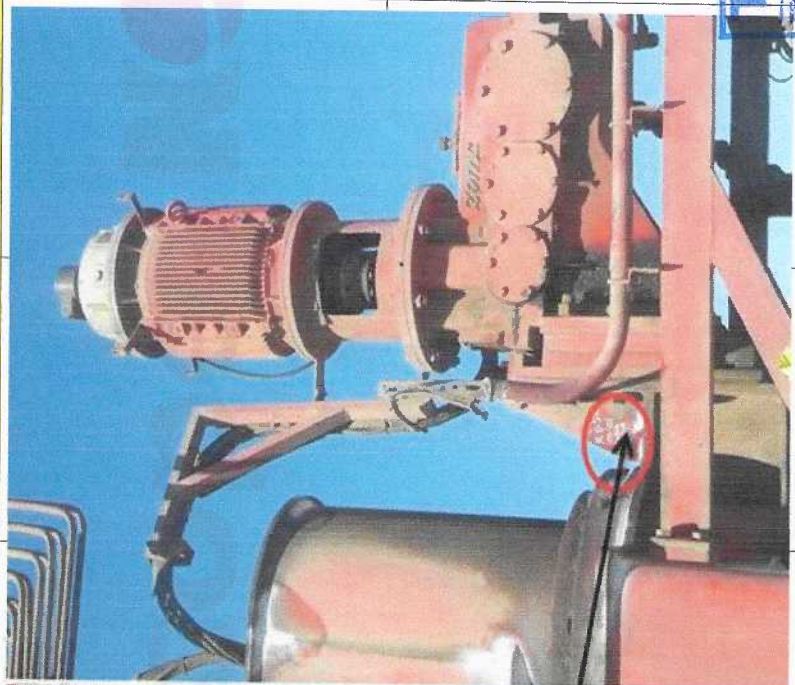
#	DATE	DRAW NO. :	Exact location	Defect description	Inspector	Pic. of defect
0	25/09/2017	DRAW NO. JL11901B	RIGHT DIESEL HOUSE SIDE MOTOR SUPPORT B6 (IN SIDE)	1 EA CRACK 2 cm	M. Asaad	
RIGHT DIESEL MOTOR SUPPORT B6 (IN SIDE)						
1

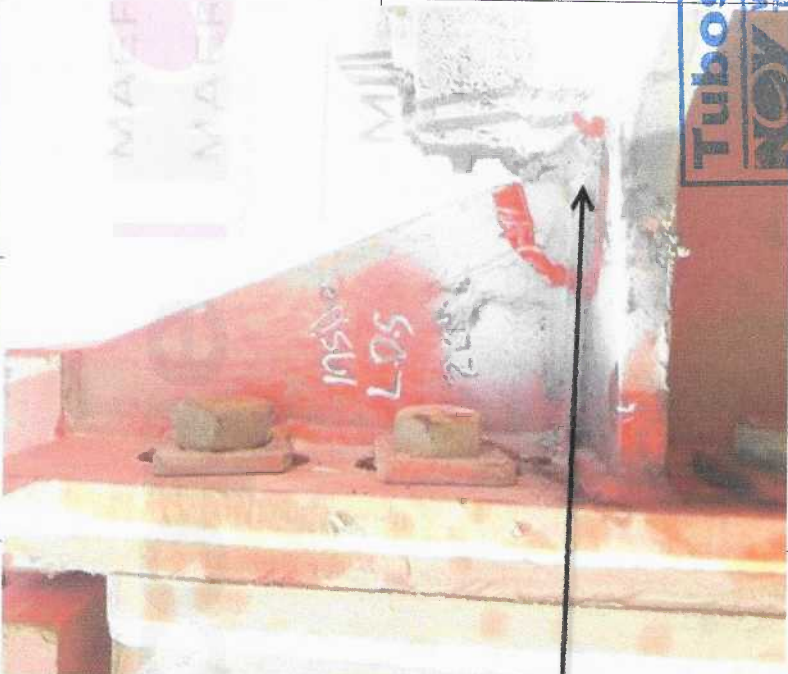
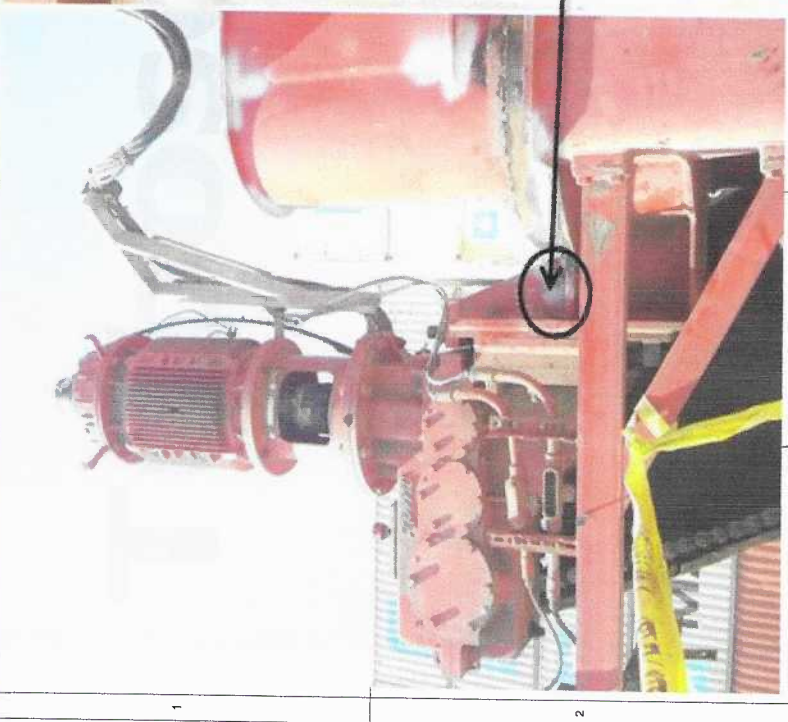
#	DATE	DRAW NO. :	Exact location	Defect description	Inspector	Pic. of defect
0	24/09/2017	DRAW NO. JL11901B	LEFT DIESEL HOUSE SIDE MOTOR SUPPORT B6 (IN SIDE)	1 EA CRACK 2 cm	M. Asaad	
LEFT DIESEL MOTOR SUPPORT B6 (IN SIDE)						
1

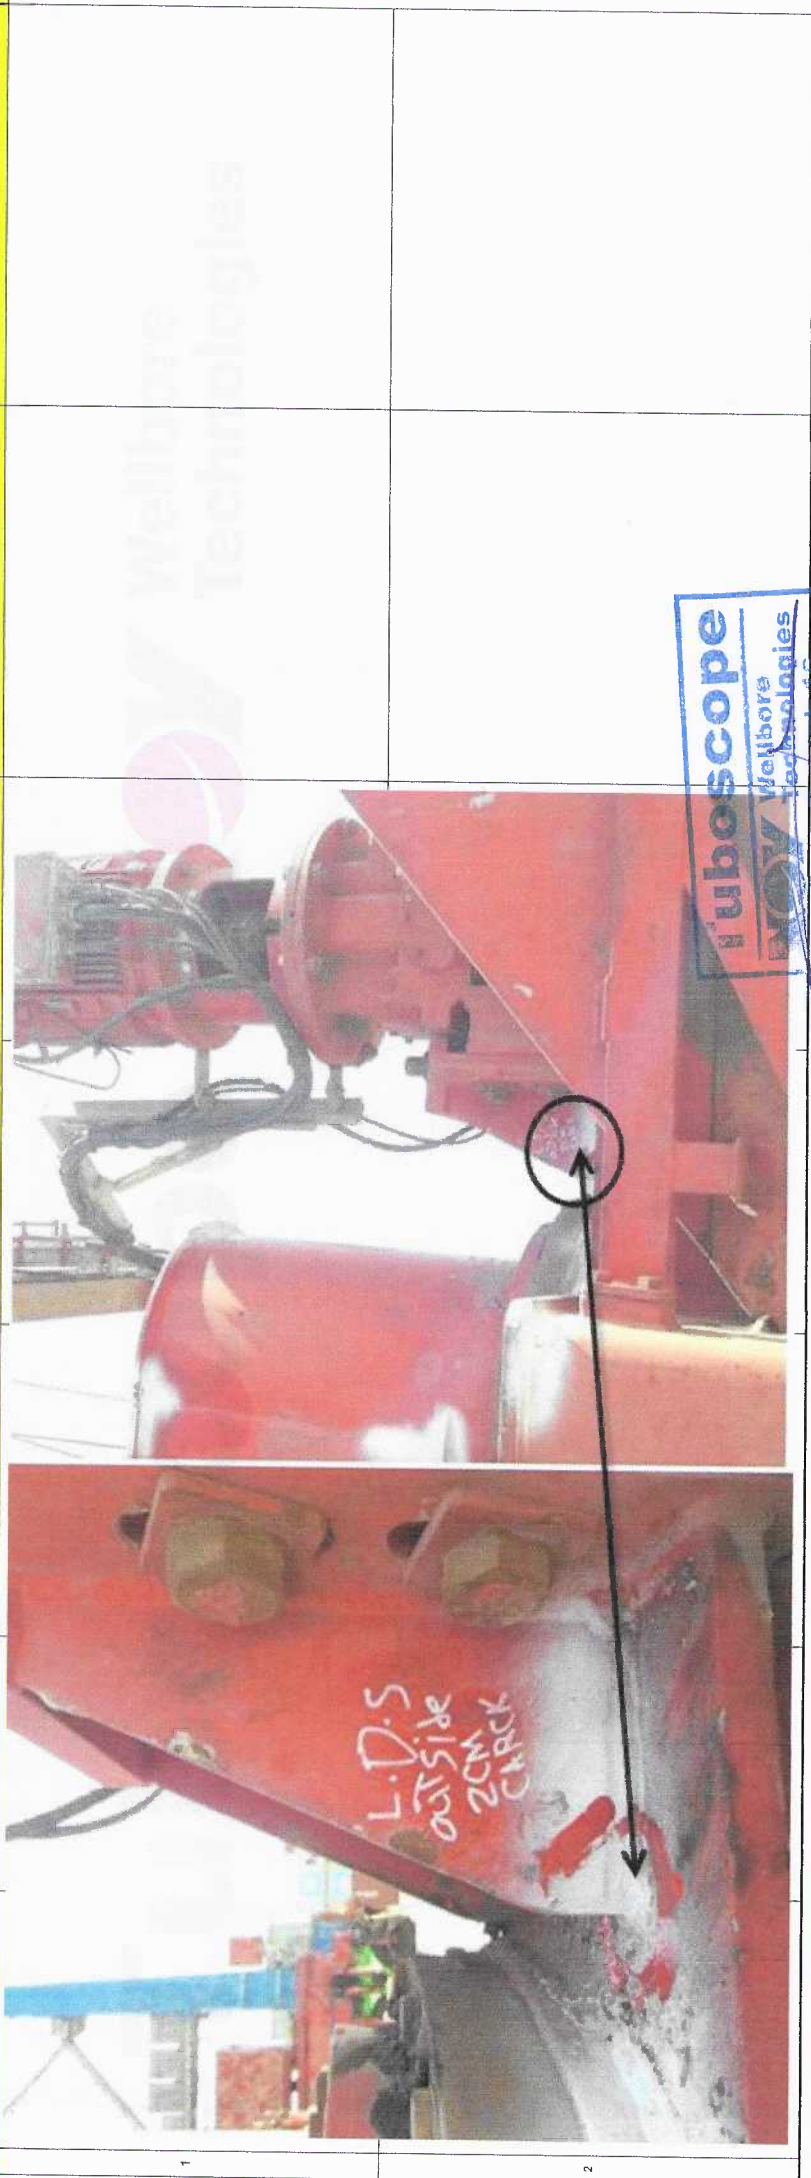
#	DATE	DRAW NO. :	Exact location	Defect description	Inspector	Pic. of defect
0	24/09/2017	DRAW NO. JL11901B	LEFT DIESEL HOUSE SIDE MOTOR SUPPORT B6 (OUTER)	1 EA CRACK 2 cm	M. Asaad	
LEFT DIESEL MOTOR SUPPORT B6 (OUTER)

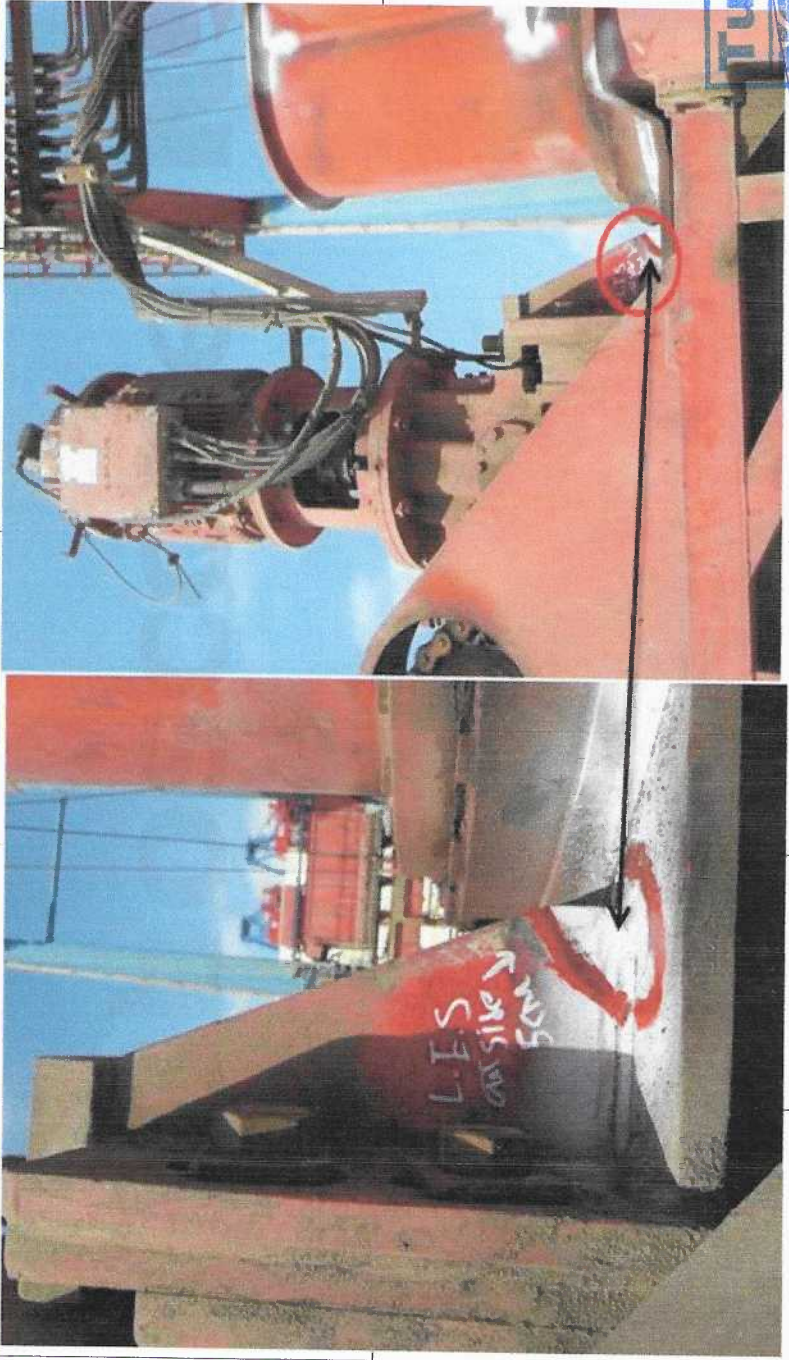
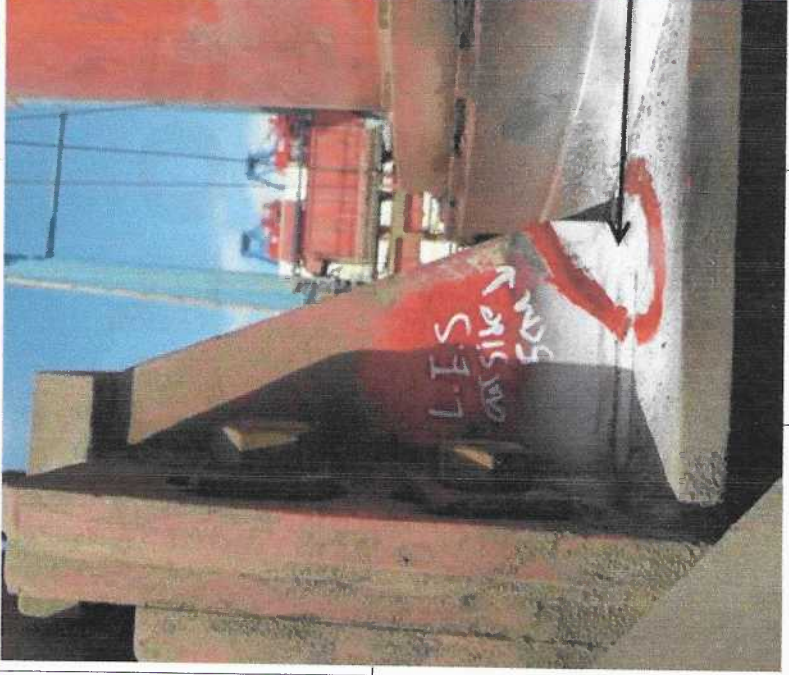
#	DATE	DRAW NO. :	Exact location	Defect description	Inspector	Pic. of defect
0	24/09/2017	DRAW NO. JL11901B	LEFT ELECTRIC HOUSE SIDE MOTOR SUPPORT B6 (OUTER)	1 EA CRACK 5 cm	M. Asaad	
LEFT ELECTRIC MOTOR SUPPORT B6 (OUTER)						
1

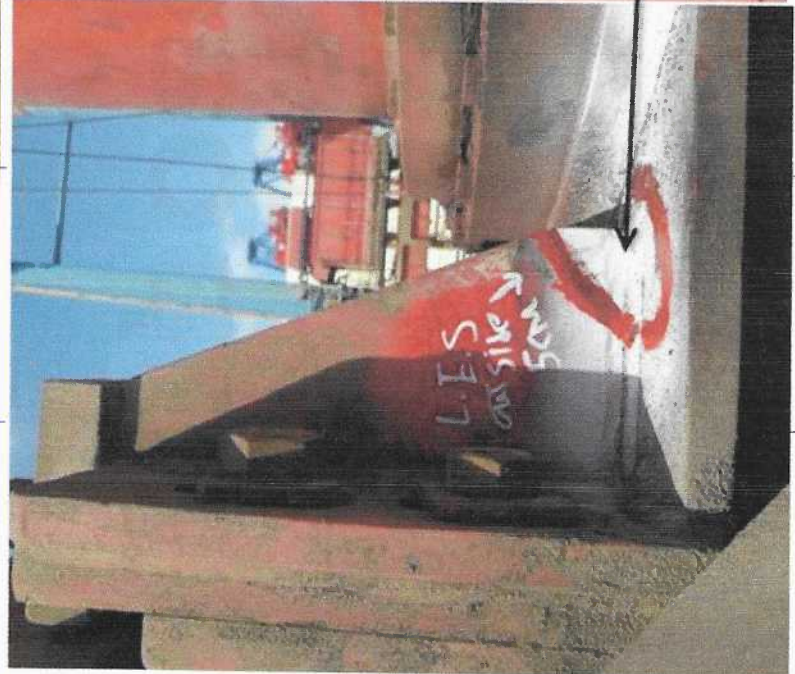
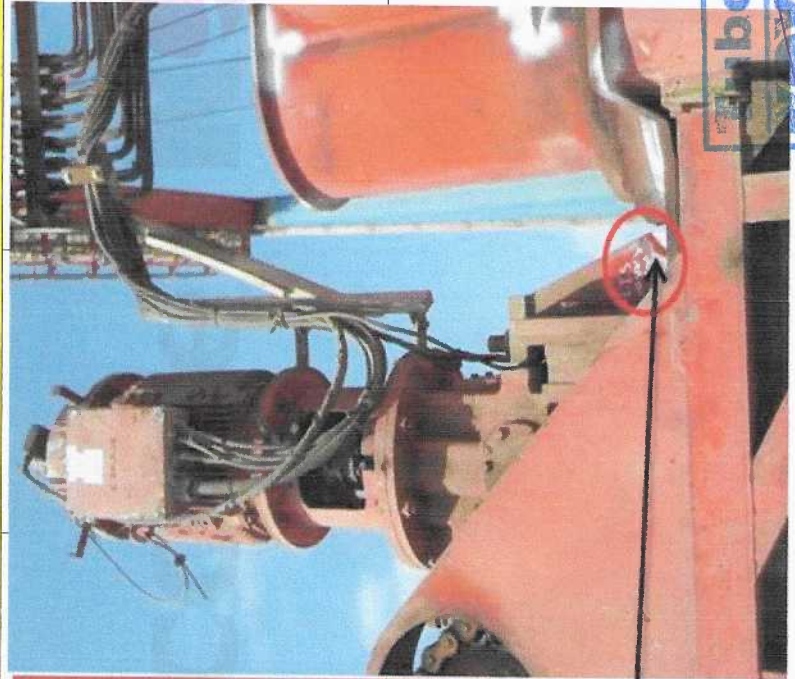
LEFT ELECTRIC MOTOR SUPPORT B6 (OUTER)

DATE	DRAW NO. :	Exact location	Defect description	Inspector	Pic. of defect
24/05/2017	DRAW NO. JL11901B	LEFT ELECTRIC HOUSE SIDE MOTOR SUPPORT B6 (OUTER)	1 EA CRACK 5 cm	M. Asaad

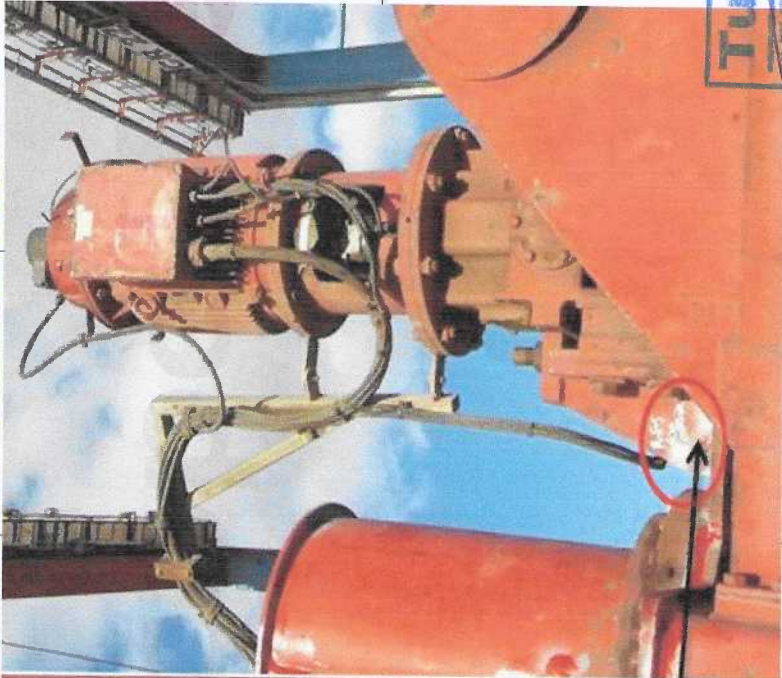
#	DATE	DRAW NO. :	Exact location	Defect description	Inspector	Pic. of defect
0	24/09/2017	DRAW NO. JL11901B	RIGHT ELECTRIC HOUSE SIDE MOTOR SUPPORT B6 (OUTER)	1 EA CRACK 6 cm	M. Asaad	
RIGHT ELECTRIC MOTOR SUPPORT B6 (OUTER)						
1

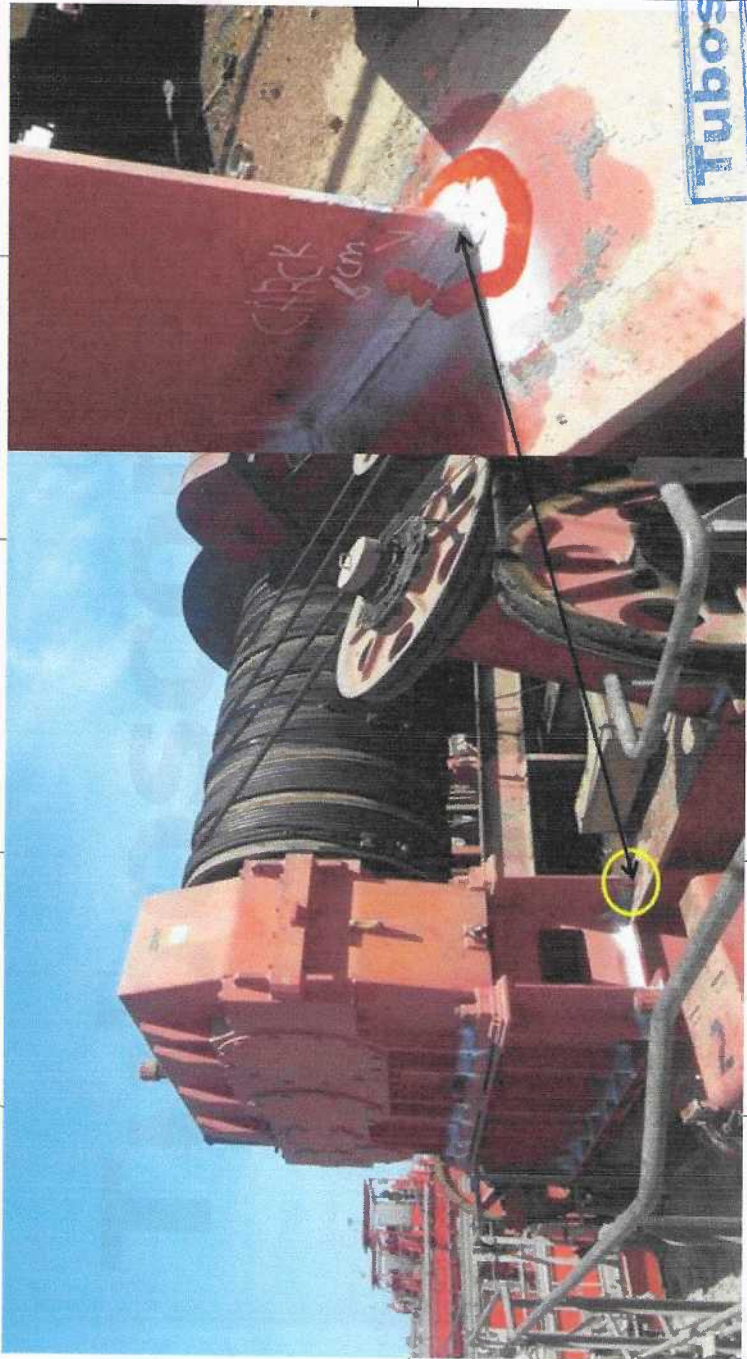
#	DATE	DRAW NO. :	Exact location	Defect description	Inspector	Pic. of defect
0	24/09/2017	DRAW NO-JL119060801	DRUM ASS	01 EA CRACK 6 CM	M. Asaad	
DRUM ASS

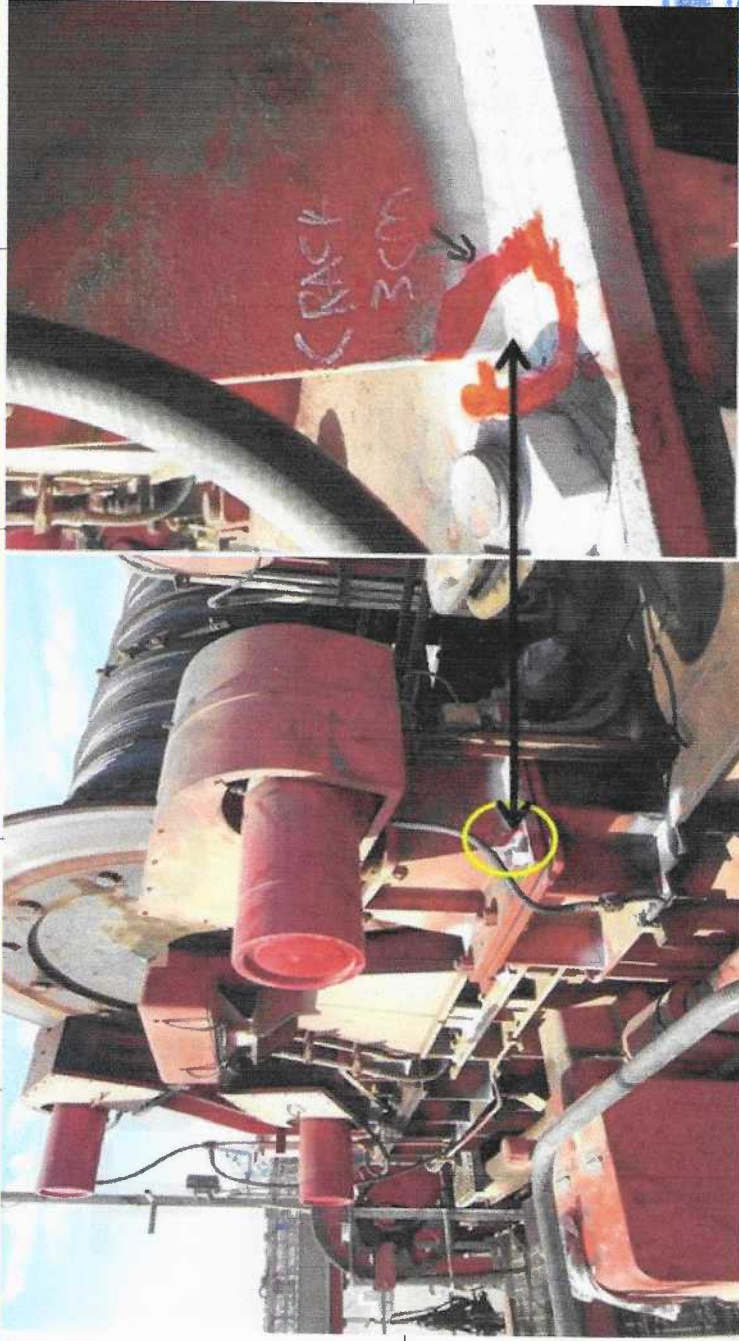
#	DATE	DRAW NO. :	Exact location	Defect description	Inspector	Pic. of defect
0	23/09/2017	DRAW NO-JL9060804	REDUCER BASE	1 EA CRACK 3 cm	M. Asaad	
REDUCER BASE

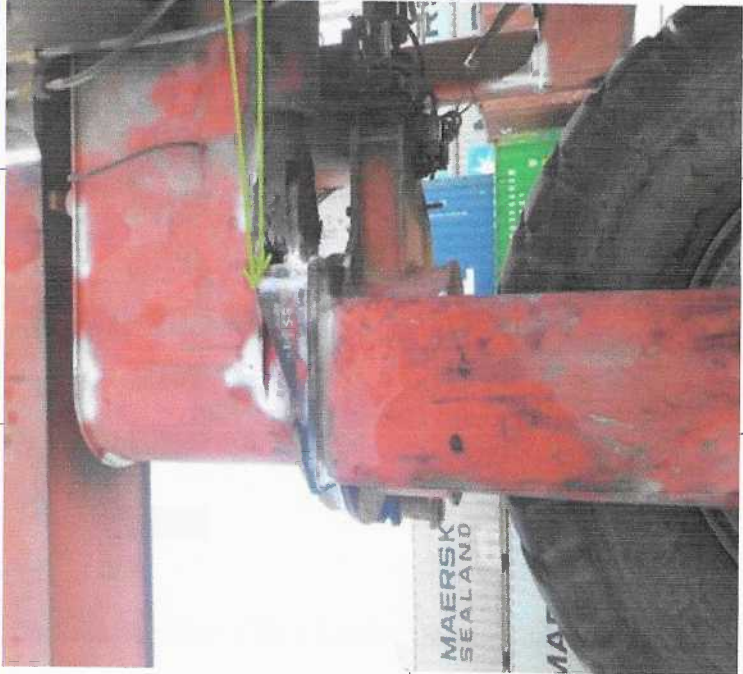
#	DATE	DRAW NO. :	Exact location	Defect description	Inspector
0	25/09/2017	DRAW NO-JL 1190104-A	LEFT ELECTRIC HOUSE SIDE STEERING & LOCKING CYLINDER - CYLINDER SUPPORT JL-1190401	2 EA CRACKS (Length = 2 cm & 4 cm)	M. Asaad
LEFT ELECTRIC HOUSE SIDE STEERING & LOCKING CYLINDER - CYLINDER SUPPORT JL-1190401					
1

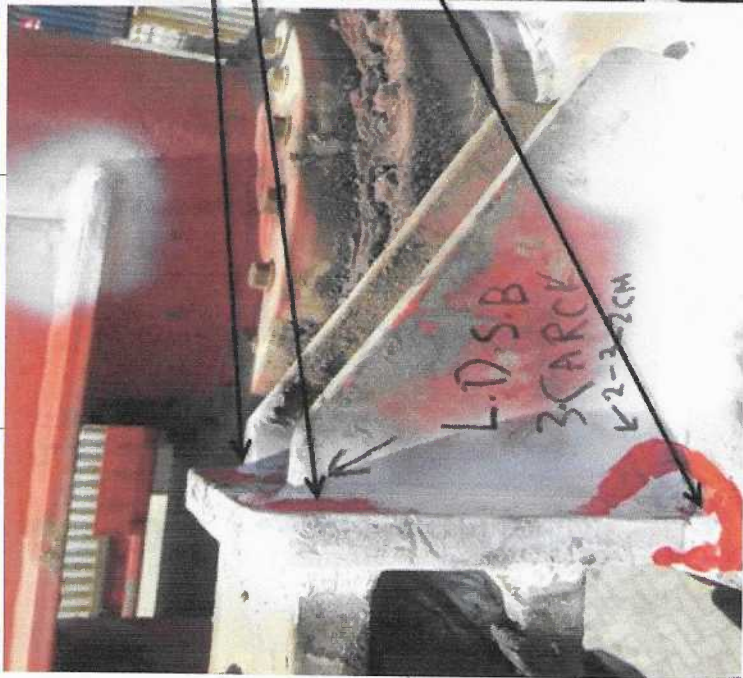
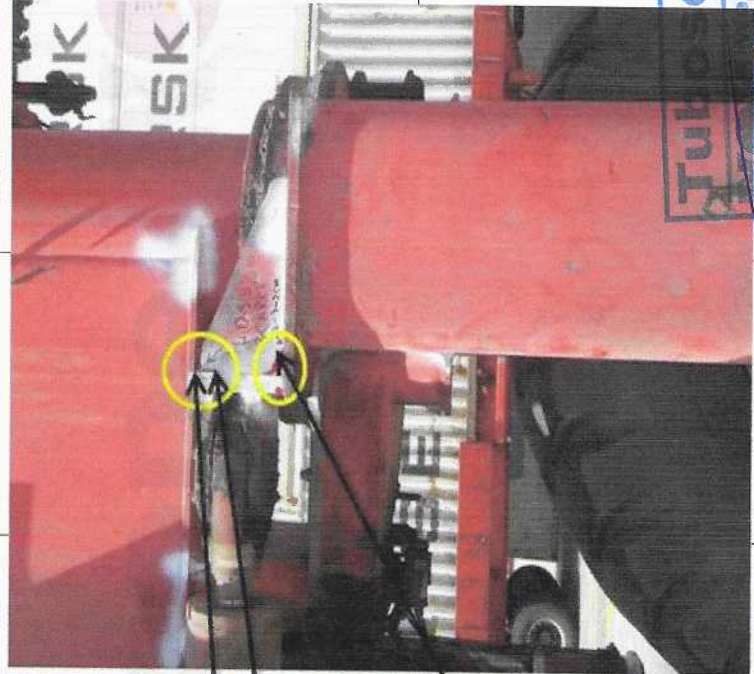
#	DATE	DRAW NO. :	Exact location	Defect description	Inspector	
0	25/09/2017	DRAW NO-JL1190104-A	LEFT DEISEL HOUSE SIDE STEERING & LOCKING CYLINDER - CYLINDER SUPPORT JL-1190401	3 EA CRACKS Length From 2cm TO 3cm TO 2 cm	M. Asaad	
LEFT DEISEL HOUSE SIDE STEERING & LOCKING CYLINDER - CYLINDER SUPPORT JL-1190401						
1

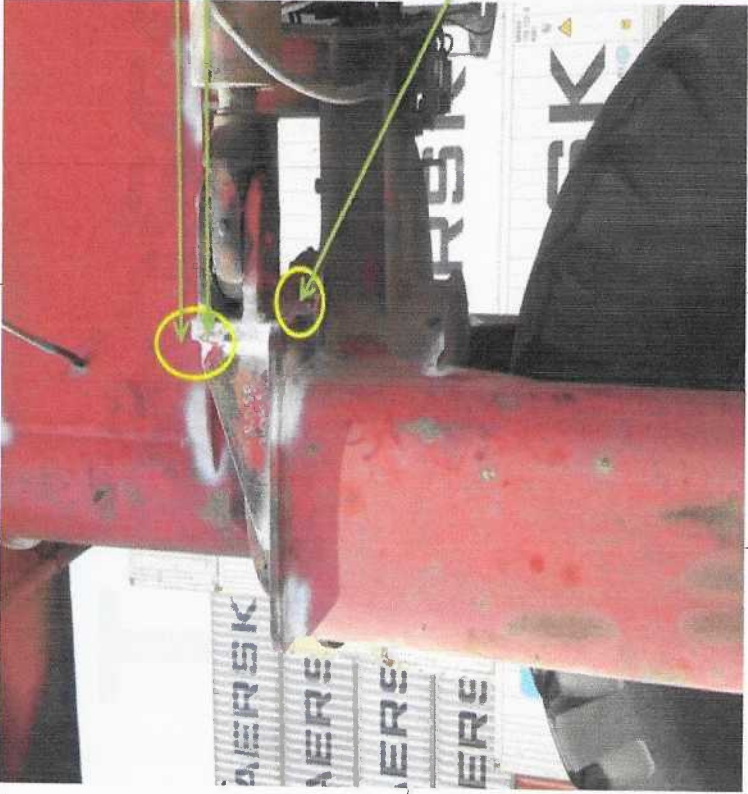
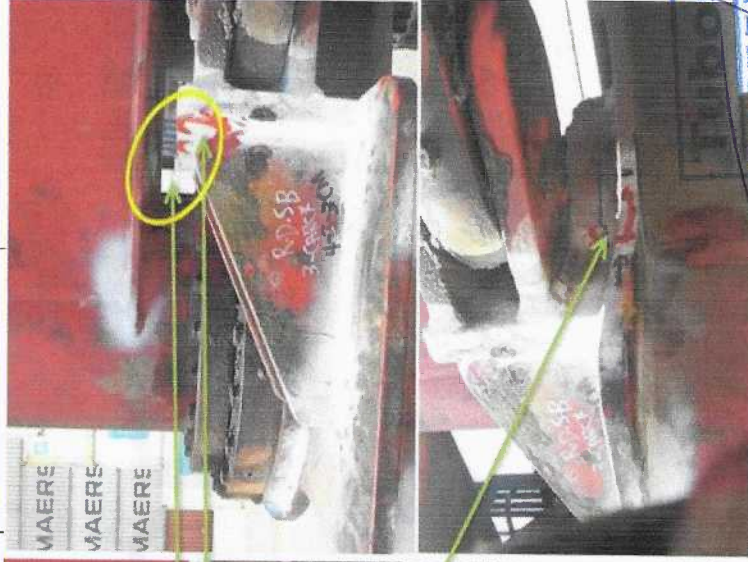
#	DATE	DRAW NO. :	Exact location	Defect description	Inspector
0	25/06/2017	DRAW NO-JL-1190104-A	RIGHT DEISEL HOUSE SIDE STEERING & LOCKING CYLINDER - CYLINDER SUPPORT JL-1190401	3 EA CRACKS Length From 4cm & 3cm & 3cm	M. Asaad
RIGHT DEISEL HOUSE SIDE STEERING & LOCKING CYLINDER - CYLINDER SUPPORT JL-1190401					
1

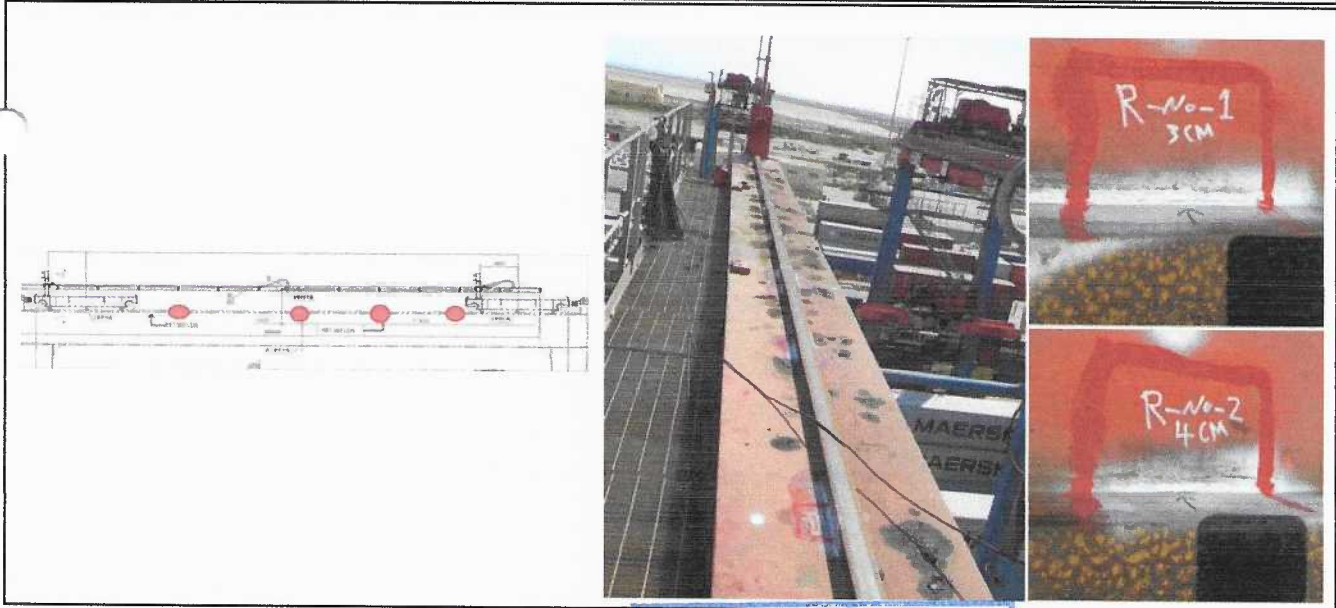
05 EA. Crack which referred by arrow as below (Length= From 2 cm To 8 cm)

After regular inspection(10% random check) several cracks we found So we decided to increase percentage of inspection to be 50 %

Need Repair

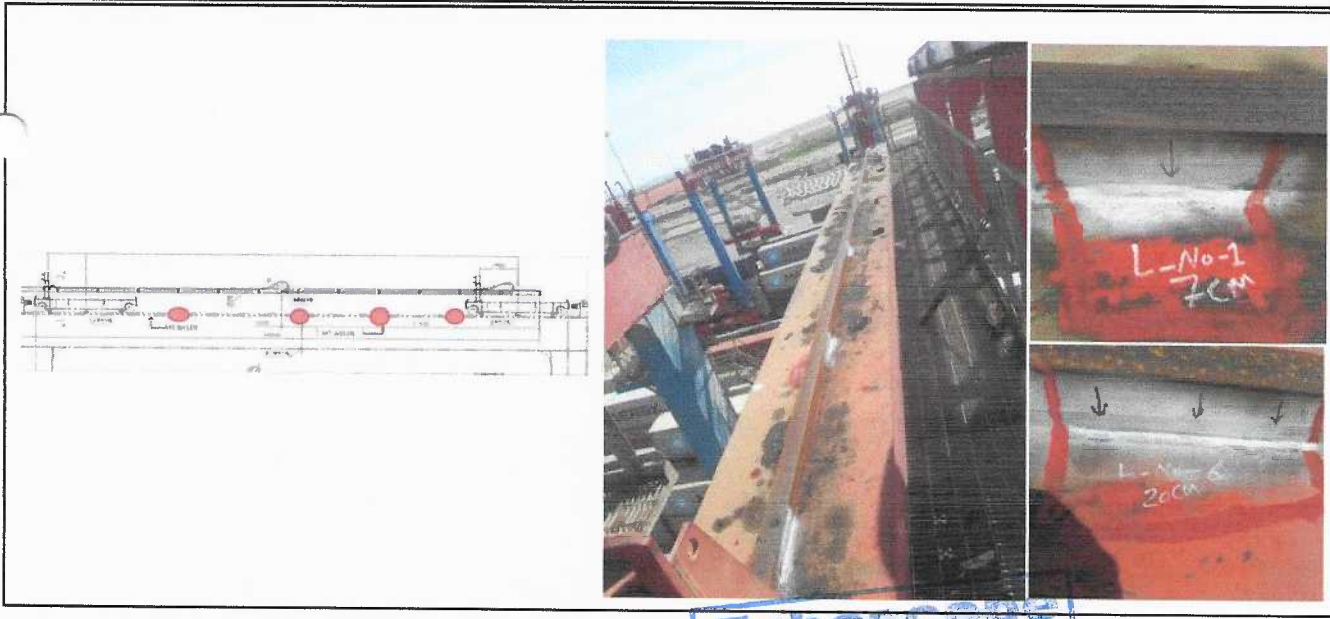
**06 EA. Crack which referred by arrow as below (Length= From 4 cm To 20 cm)
Need Repair**

After regular inspection(10% random check) several cracks we found So we decided to increase percentage of inspection to be 50 %

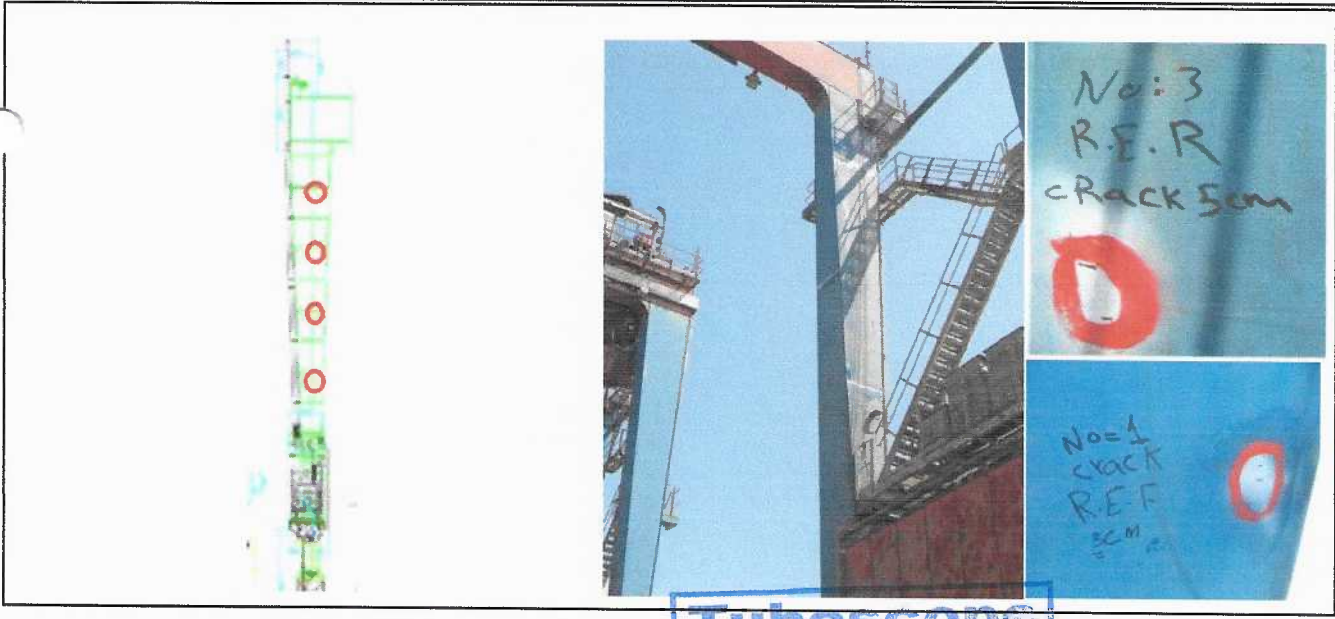
05 EA. Crack which referred by arrow as below (Length = Form 03 cm To 6 cm)

Need Repair

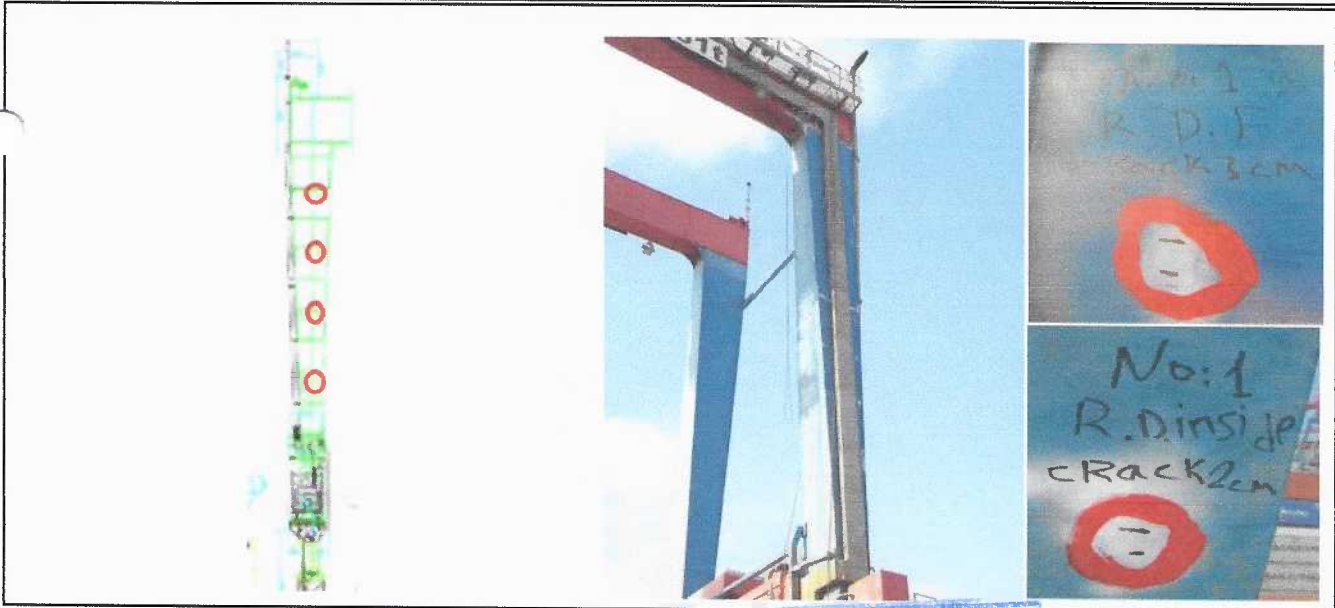
08 EA. Crack which referred by arrow as below (Length = Form 2 cm To 5 cm)

Need Repair

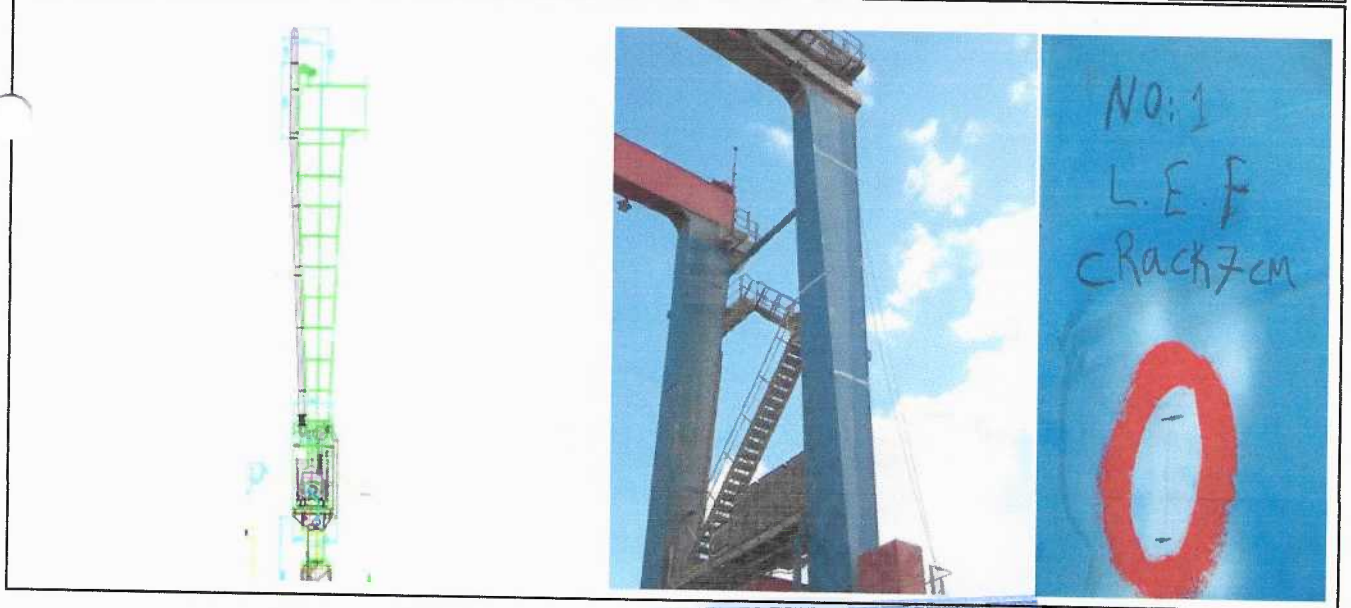
01 EA. Crack which referred by arrow as below (Length 7 cm)

Need Repair

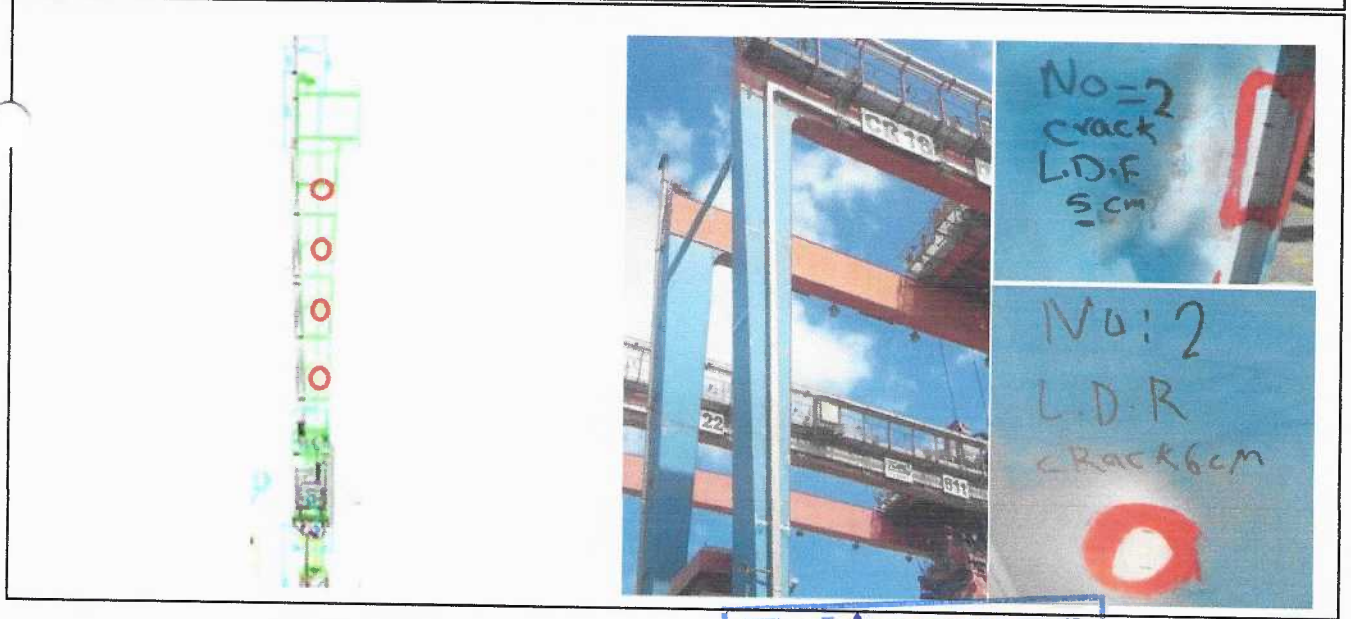
05 EA. Crack which referred by arrow as below (Length= From 3 cm To 6 cm)

Need Repair

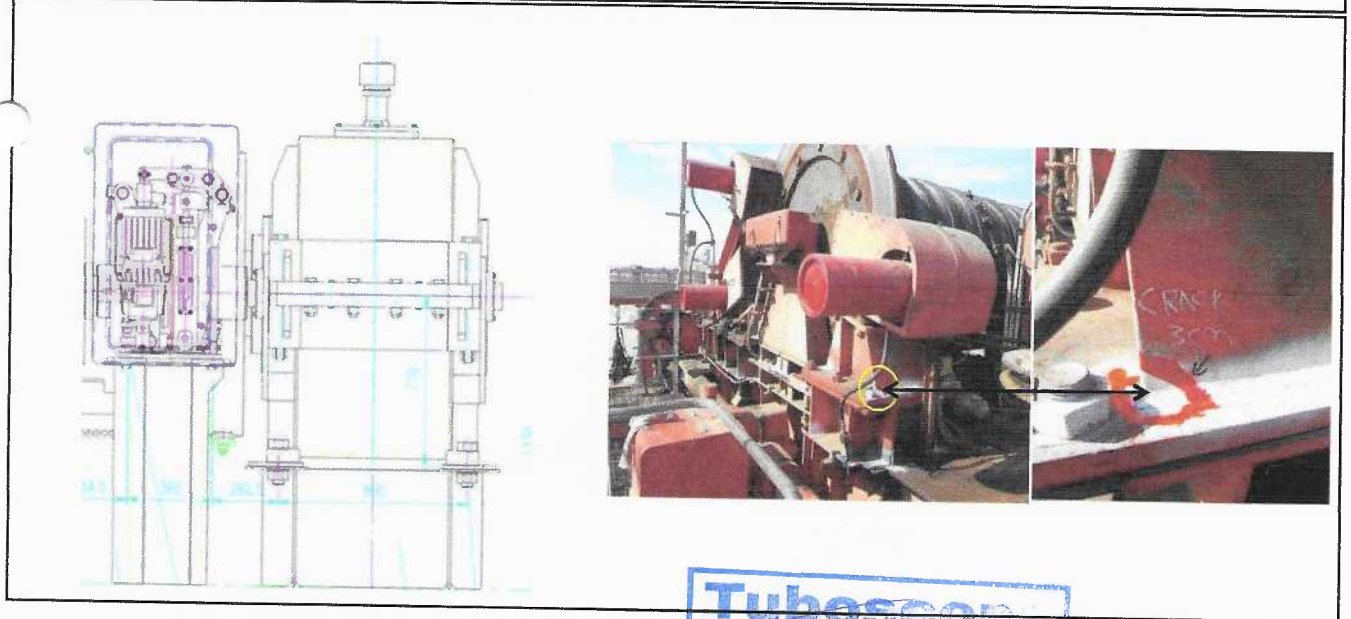
1 EA. Crack which referred by arrow as below (Length 3 cm)

Need Repair

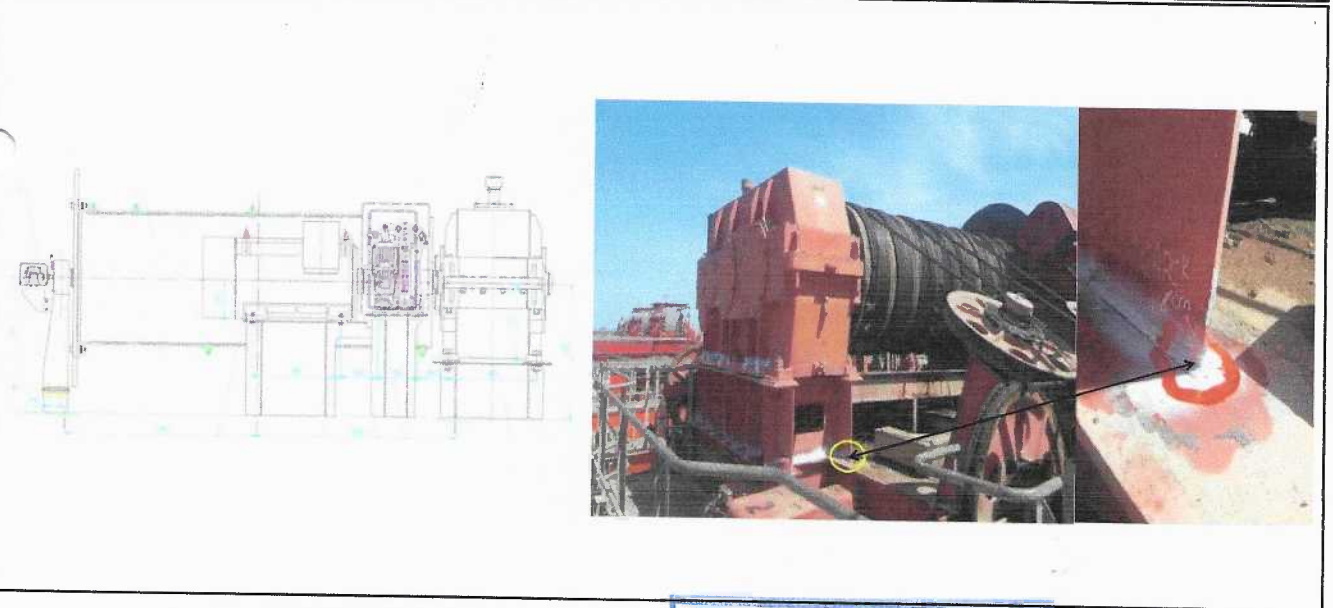
01 EA. Crack which referred by arrow as below (Length 6 cm)

Need Repair

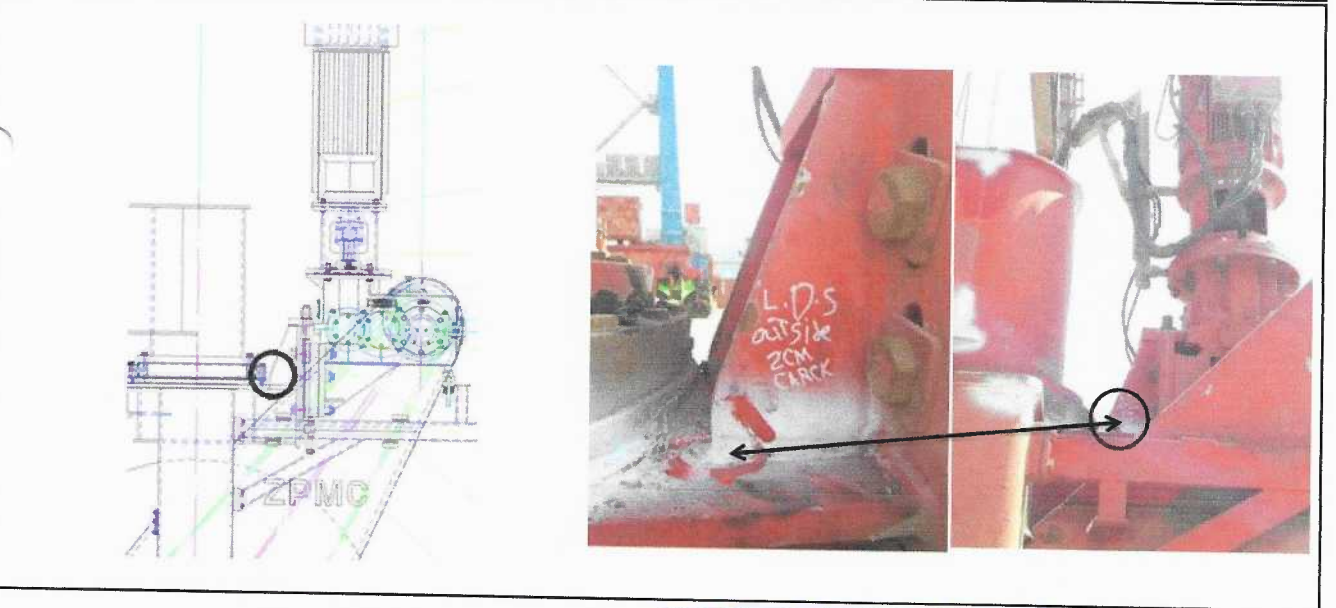
01 EA. Crack which referred by arrow as below (Length 2 cm)

Need Repair
