NDT Inspection
<https://tuboafrika.nov.com/>

Client
Suez Canal Container Terminal

RTG Crane
CR 16

Summary of Inspection

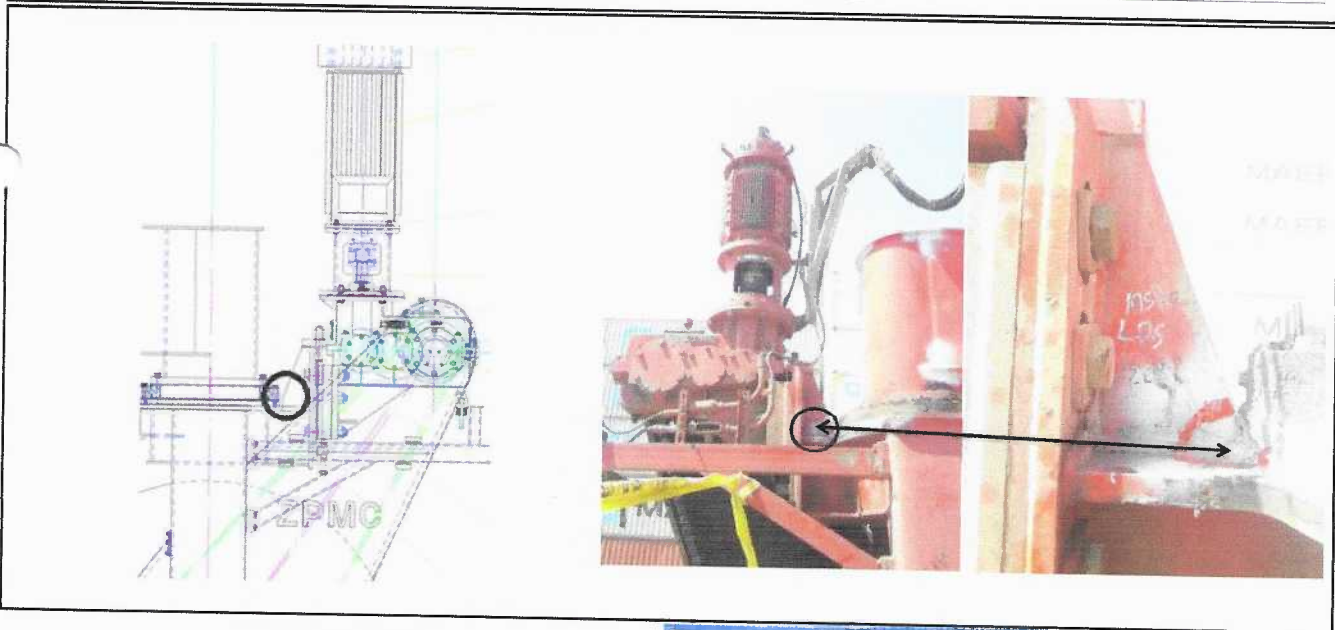
01 EA. Crack which referred by arrow as below (Length 2 cm)

Need Repair

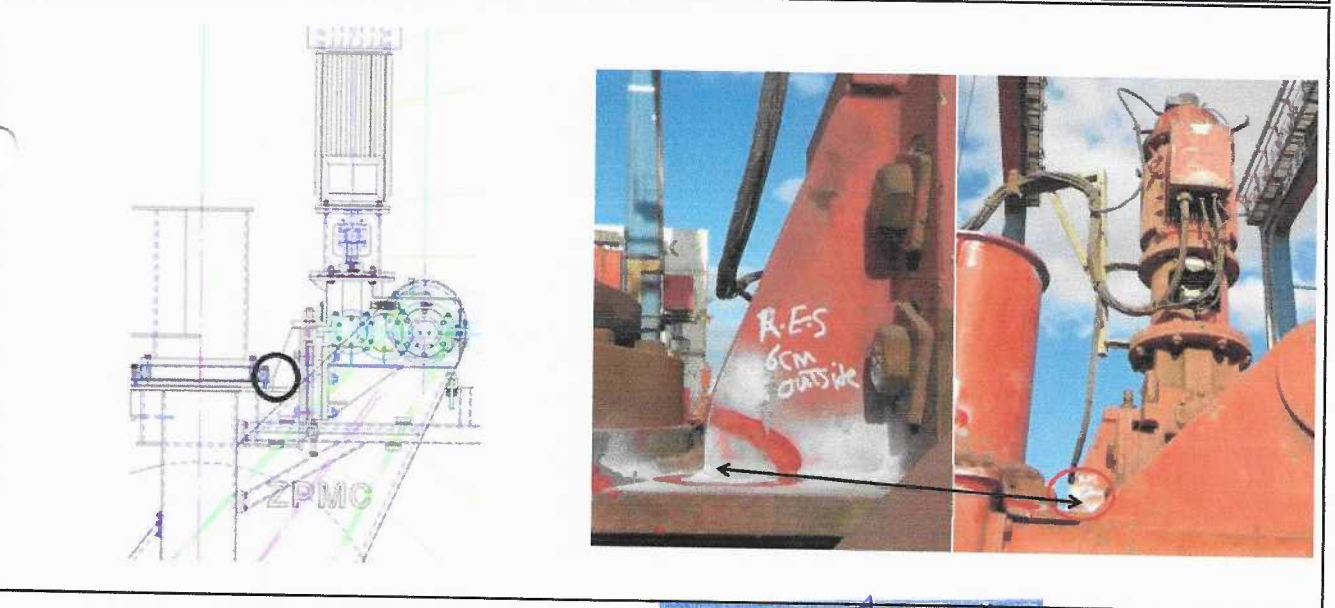
01 EA. Crack which referred by arrow as below (Length 6 cm)

Need Repair

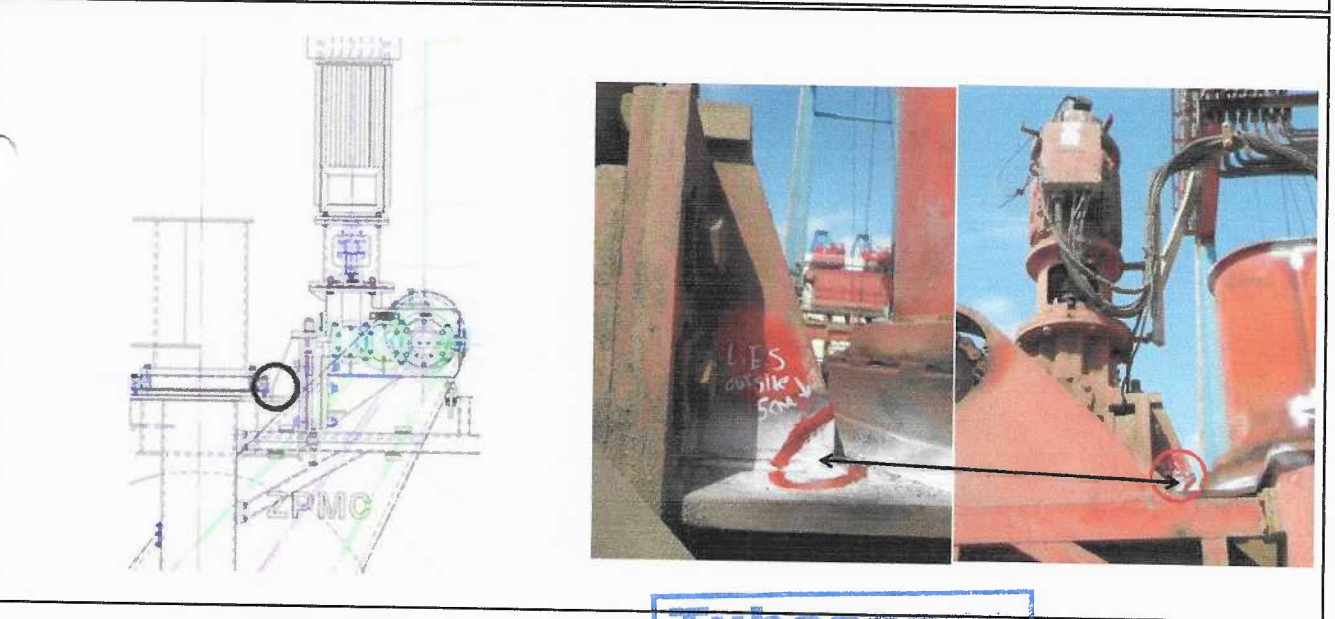
01 EA. Crack which referred by arrow as below (Length 5 cm)

Need Repair

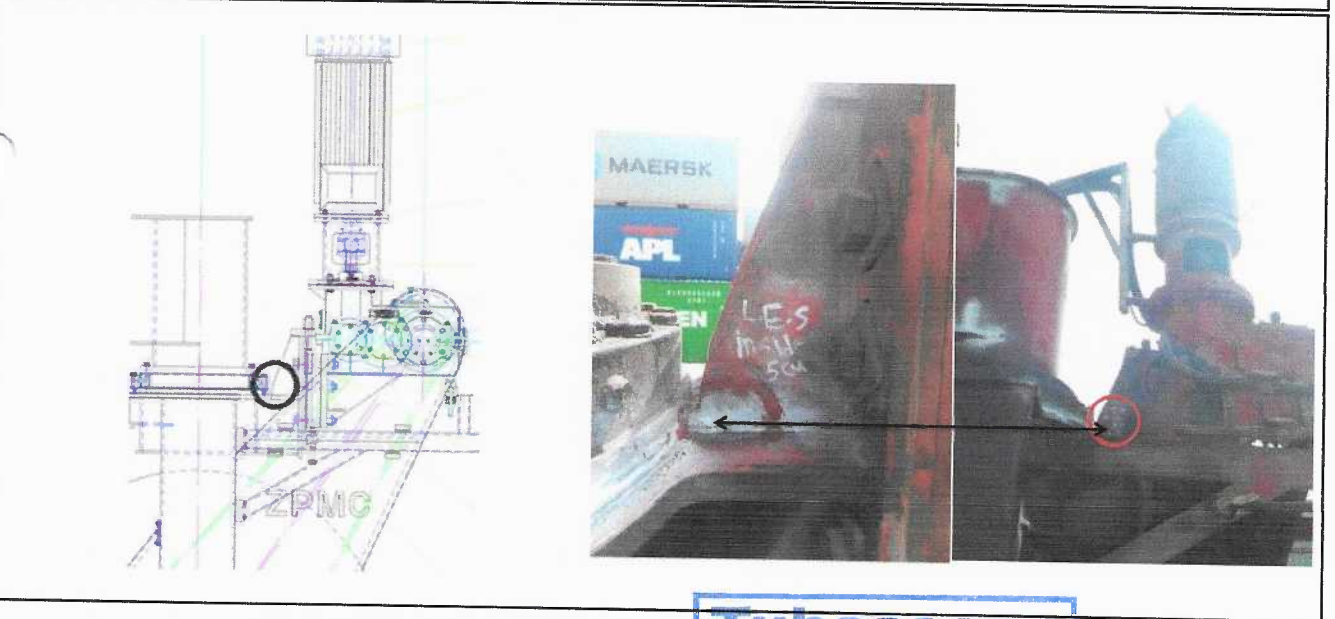
01 EA. Crack which referred by arrow as below (Length 5 cm)

Need Repair

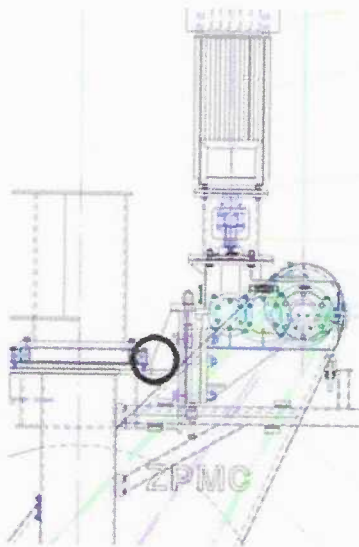
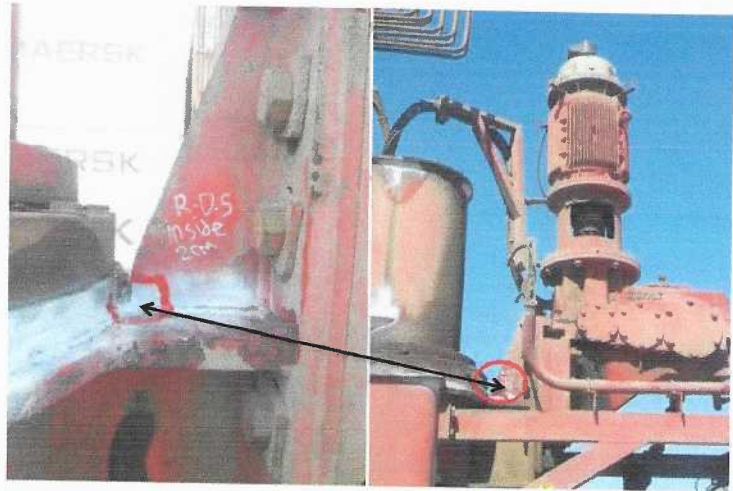
01 EA. Crack which referred by arrow as below (Length 2 cm)

Need Repair

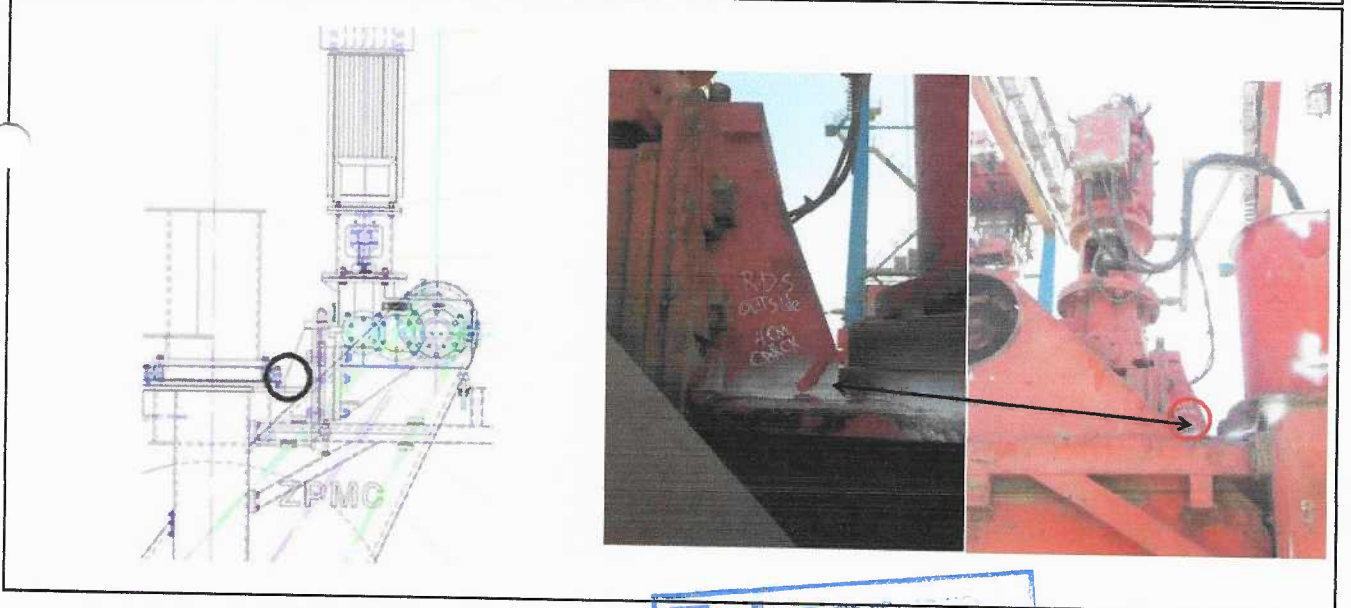
01 EA. Crack which referred by arrow as below (Length 4 cm)

Need Repair

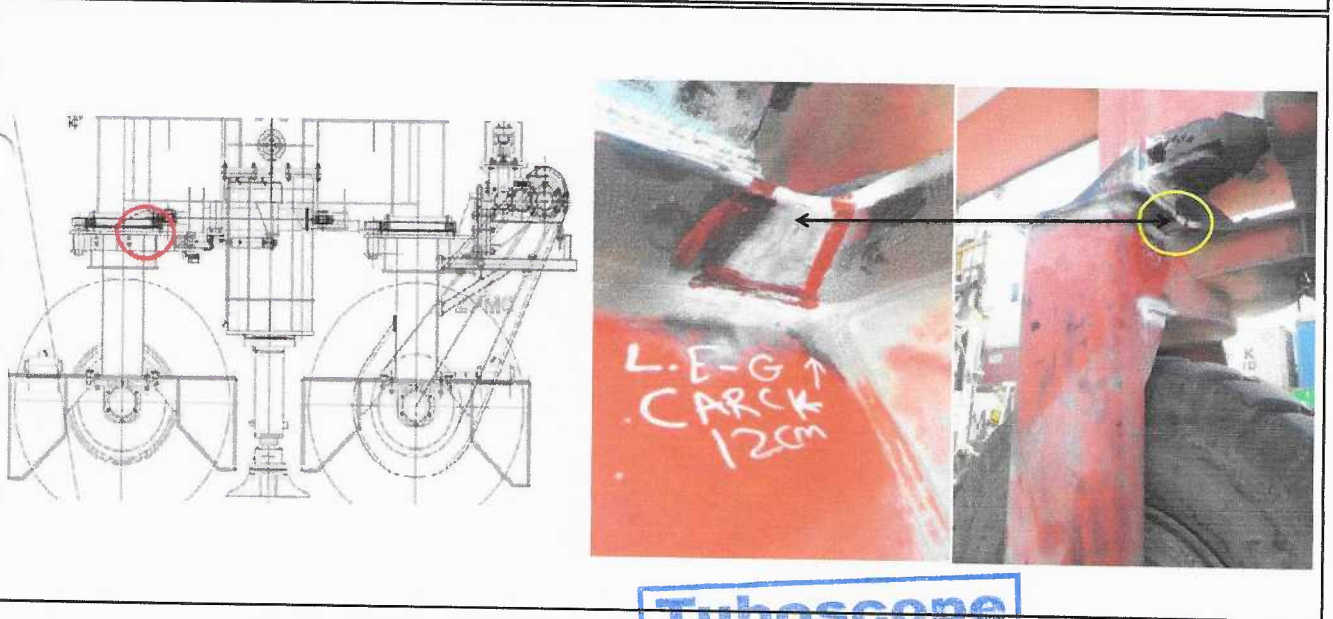
01 EA. Crack which referred by arrow as below (Length 12 cm)

Need Repair

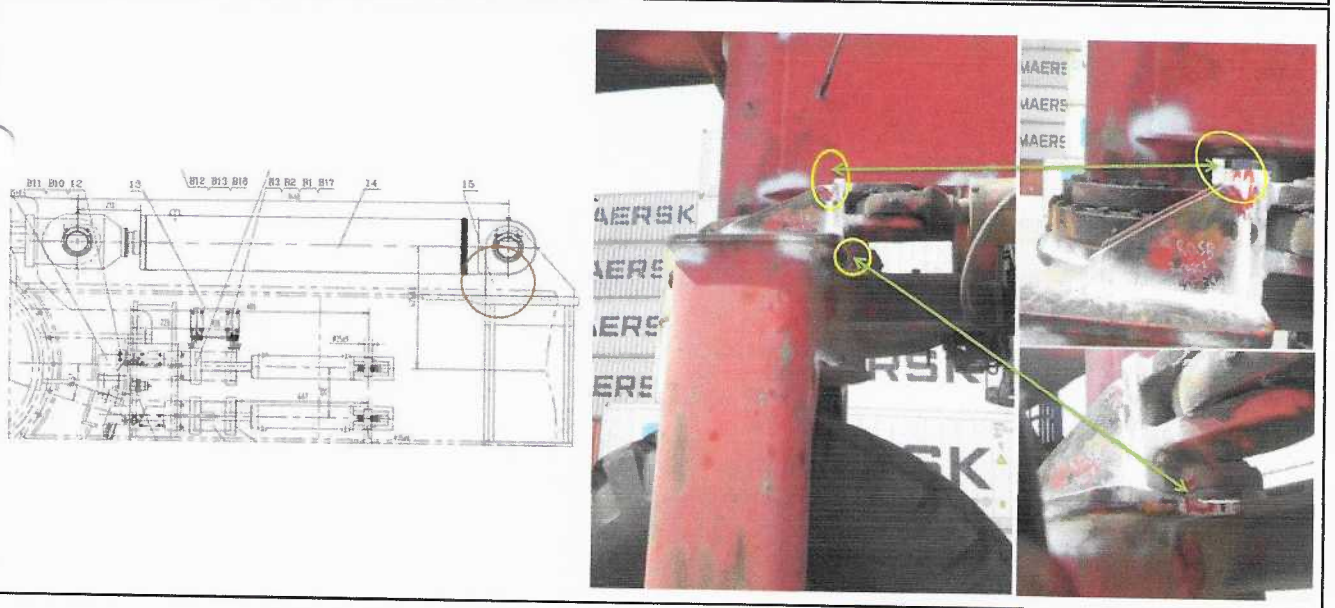
3 EA. Crack which referred by arrow as below (Length = Form 04 cm - 3 cm - 3 cm)

Need Repair

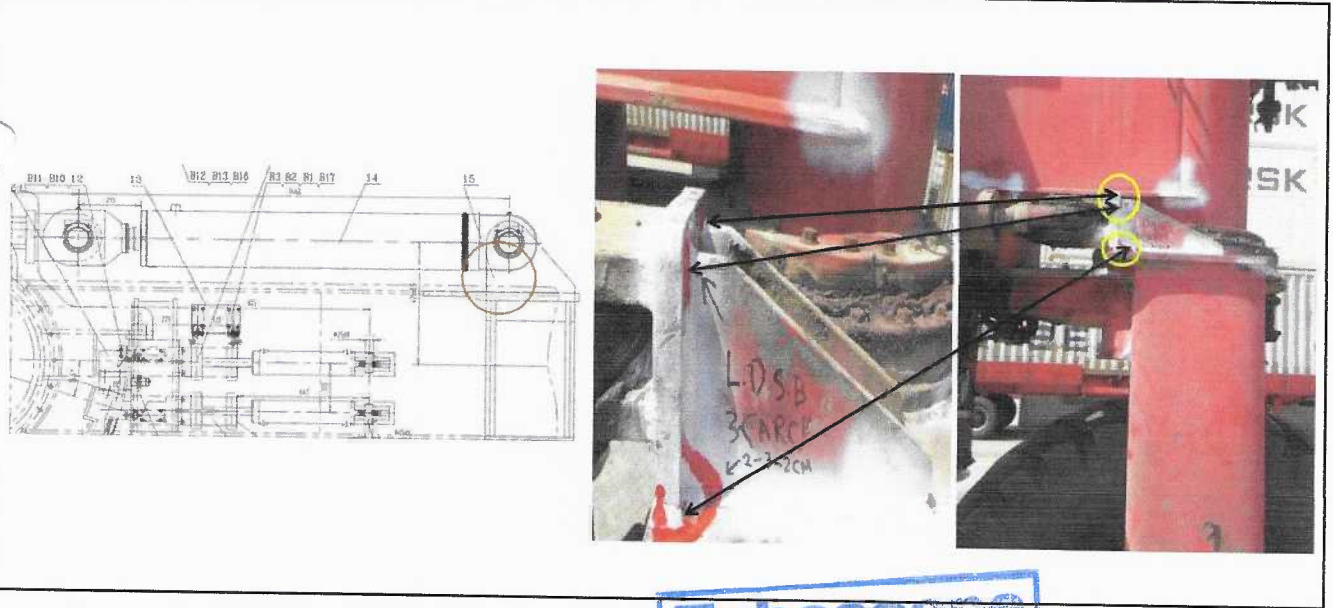
3 EA. Crack which referred by arrow as below (Length = Form 2 cm - 3 cm - 2 cm)

Need Repair

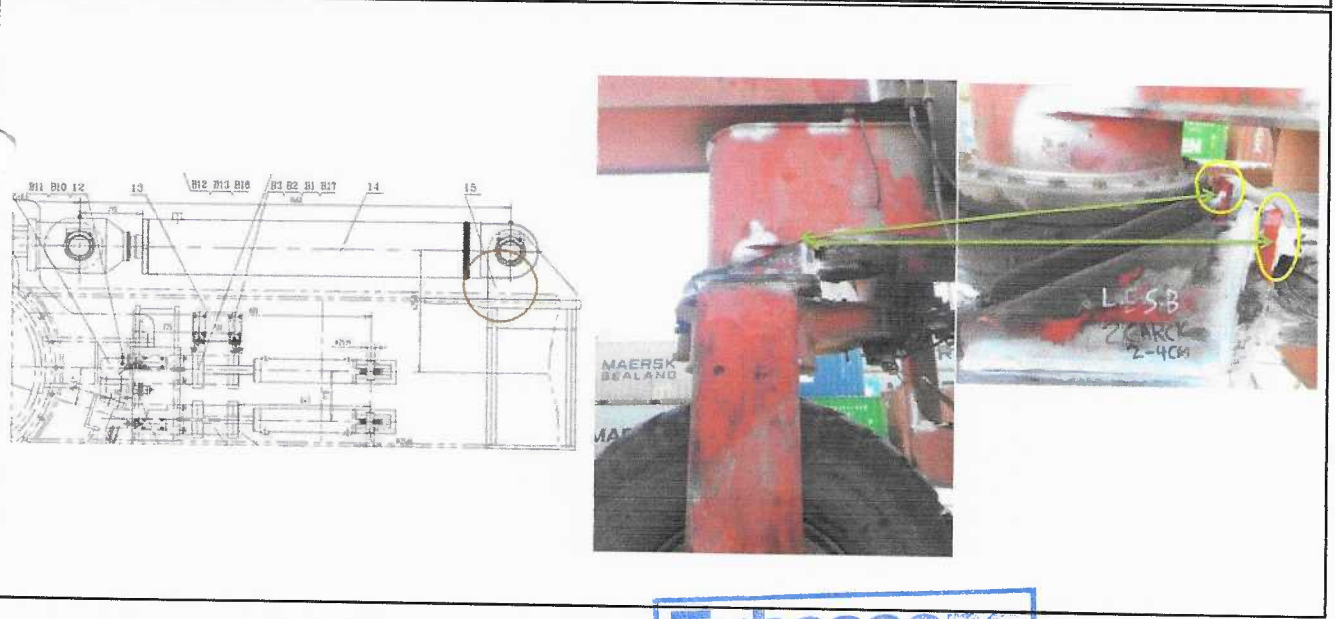
2 EA. Crack which referred by arrow as below (Length = Form 2 cm - 4 cm)

Need Repair

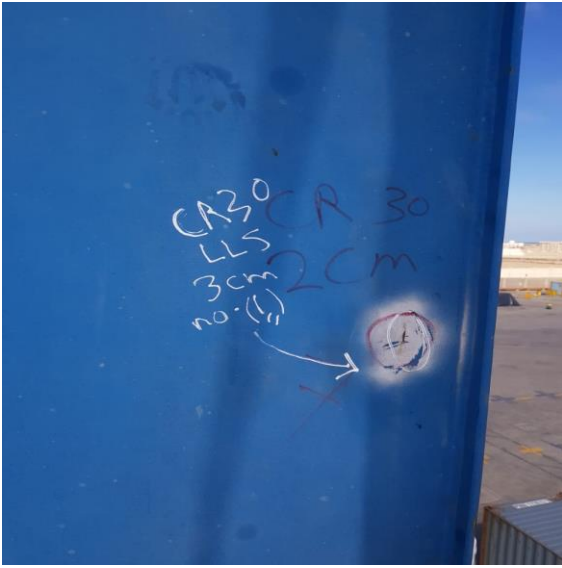
Figure No. (1)

Crack No.:	Length (cm)	Location	Figure No.:	CORRECTIVE ACTION
1	3.0	{LLS}	1	As per SCCT Recommendations
2	4.0	{LLS}	2	As per SCCT Recommendations
3	4.5	{LLS}	3	As per SCCT Recommendations
4	3.0	{LLS}	4	As per SCCT Recommendations

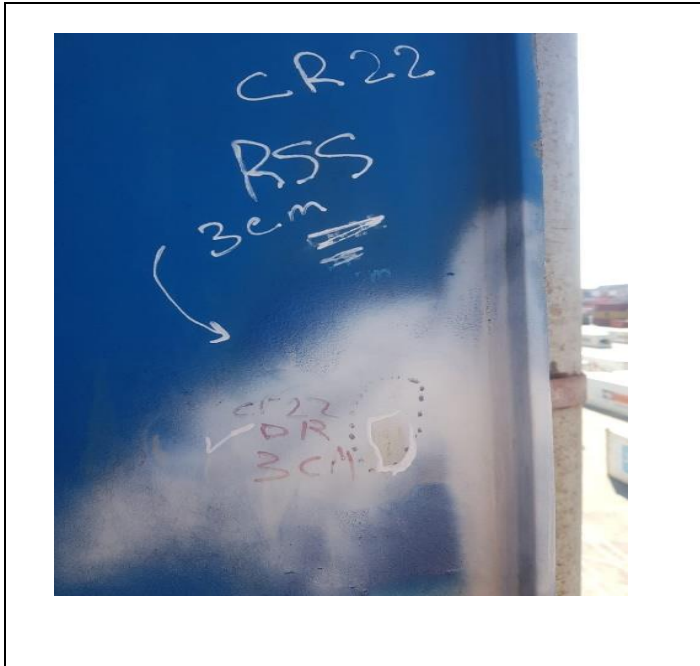
Figure No. (1)

Crack No.:	Length (cm)	Location	Figure No.:	CORRECTIVE ACTION
1	3.0	{RSS}	1	As per SCCT Recommendations
2	4.0	{RLS}	2	As per SCCT Recommendations
3	3.0	{LLS}	3	As per SCCT Recommendations
4	4.0	{LSS}	4	As per SCCT Recommendations
5	2.0	{LSS}	5	As per SCCT Recommendations

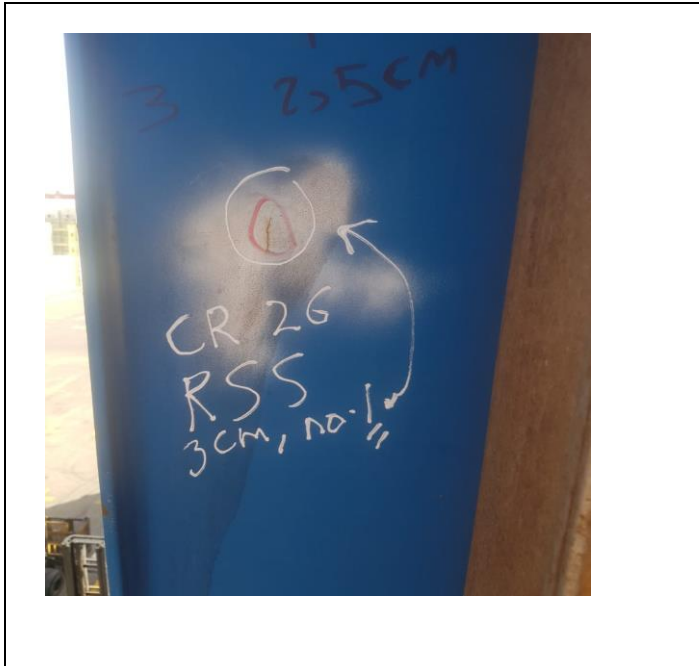
Figure No. (1)

Crack No.:	Length (cm)	Location	Figure No.:	CORRECTIVE ACTION
1	3.0	{RSS}	1	As per SCCT Recommendations
2	2.5	{RSS}	2	As per SCCT Recommendations
3	1.25	{LSS}	3	As per SCCT Recommendations
