NDT Inspection
<https://tuboafrika.nov.com/>

Client
Suez Canal Container Terminal

RTG Crane
CR 16

Summary of Inspection

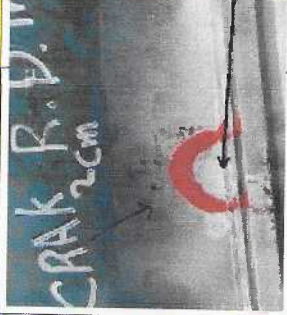
RIGHT LEG OF DIESEL HOUSE SIDE (IN SIDE)							
1

#	DATE	T.V. Work Order No. : Customer :	SD-119039 SUZUKI CANAL CONTAINER TERMINAL	Customer W.O. No. Work location	Inspector	Defect description	Pic. of defect
0	23/09/2017	DRAW NO. : DRAW NO. JL1190301A	NO-2 RIGHT LEG OF DIESEL HOUSE SIDE (IN SIDE & RAER)		M. Asaad	03 EA CRACKS MIN 2 cm & MIX 4cm

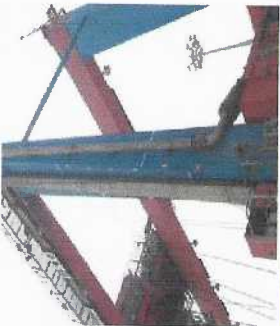
RIGHT LEG OF DIESEL HOUSE SIDE (FORNT)						
1

#	DATE	DRAW NO. :	Exact location	Defect description	Inspector	Pic. of defect
0	23/09/2017	DRAW NO.JL1190301A	NO-2 RIGHT LEG OF DIESEL HOUSE SIDE (FORNT)	(05 EA CRACKS MIN 2 cm & MIX 5 cm)	M. Asaad

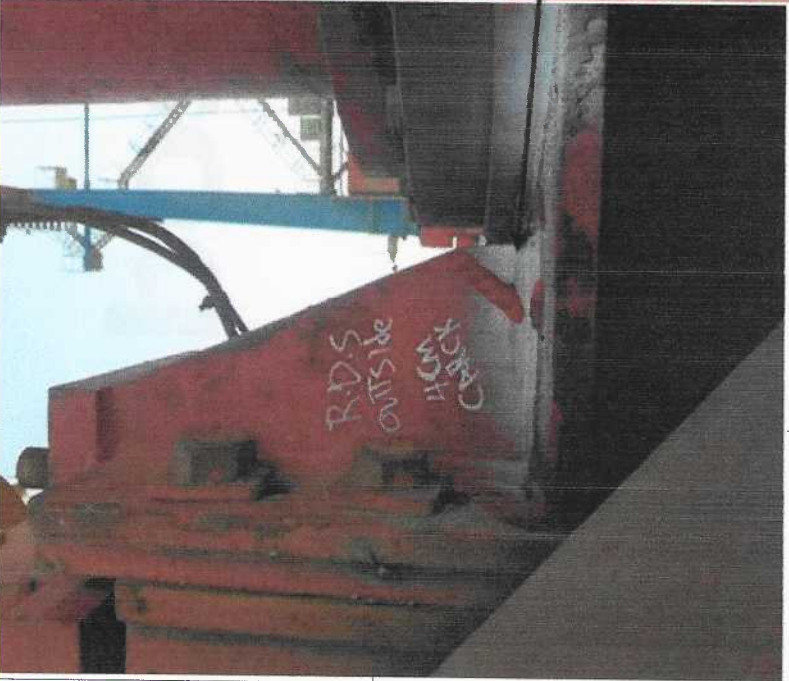
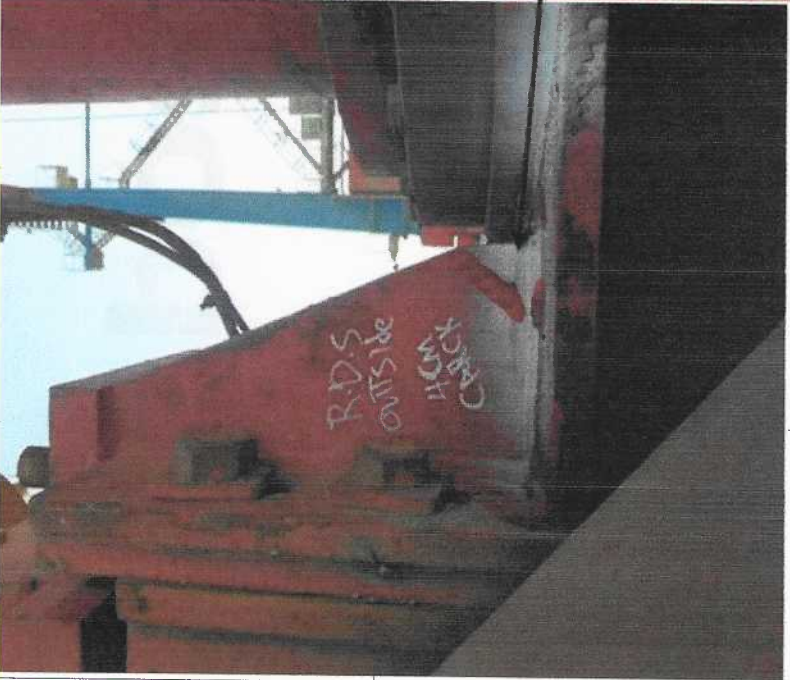
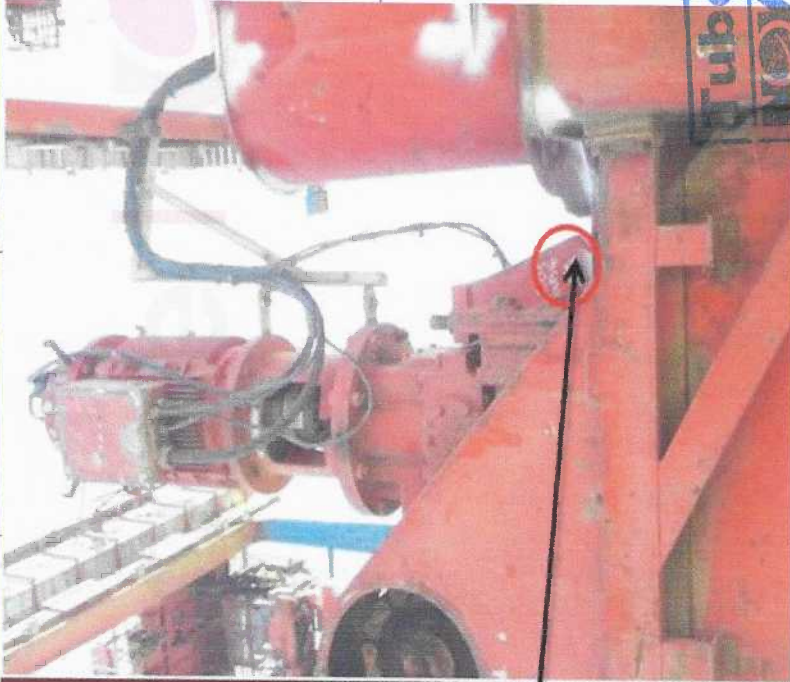
#	DATE	DRAW NO. :	Exact location	Defect description	Inspector	Pic. of defect
0	25/09/2017	DRAW NO. JL11901B	RIGHT DIESEL HOUSE SIDE MOTOR SUPPORT B6 (OUTER)	1 EA CRACK 4 cm	M. Asaad	
RIGHT DIESEL MOTOR SUPPORT B6 (OUTER)						
1

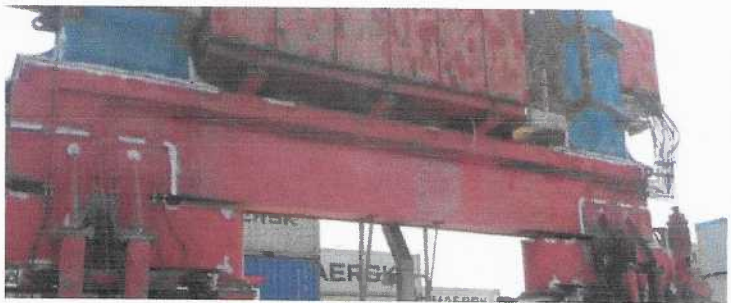
**MPI carried out on available welding areas and found free from surface crack at
time of inspection**

ACCEPTED

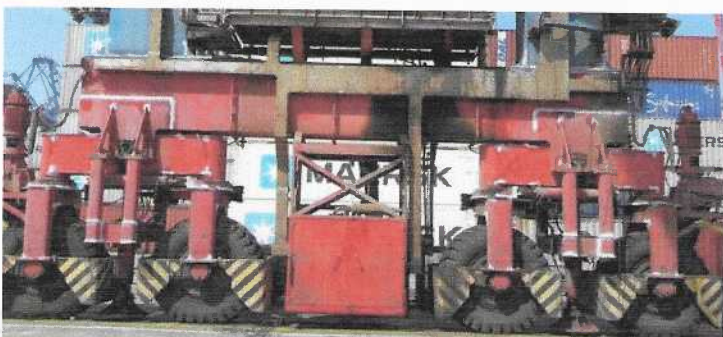
MPI carried out on available welding areas and found free from surface crack at time of inspection

ACCEPTED

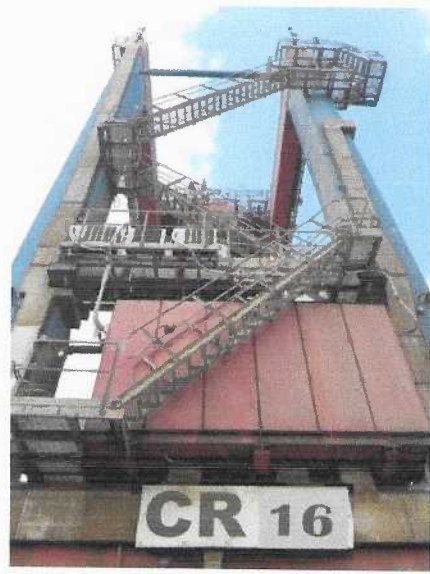
MPI carried out on available welding areas and found free from surface crack at time of inspection

ACCEPTED

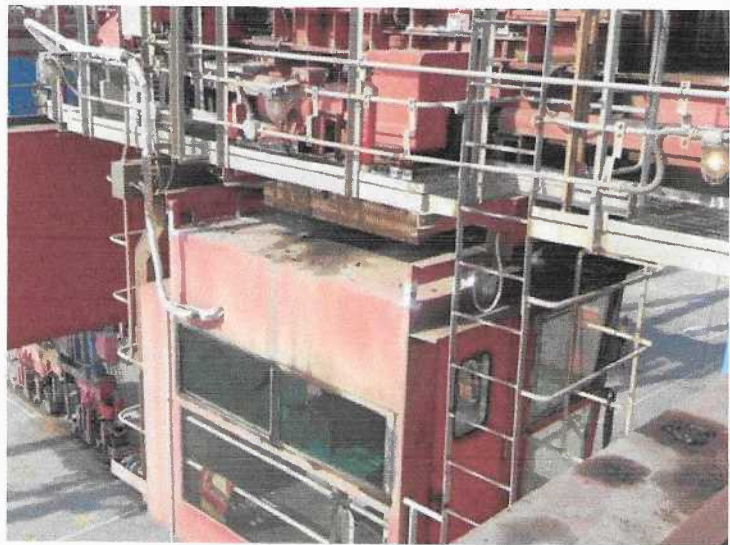
**MPI carried out on available welding areas and found free from surface crack at
time of inspection**

ACCEPTED

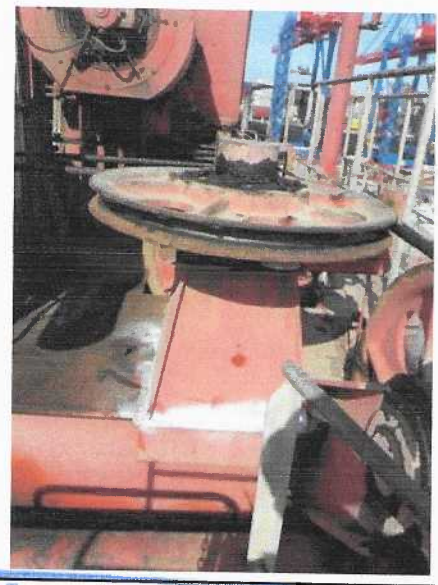
MPI carried out on available welding areas and found free from surface crack at time of inspection

ACCEPTED

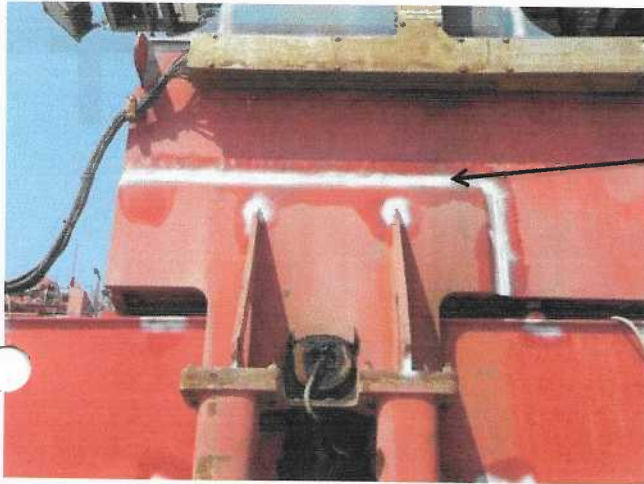
**** UT . SHEAR WAVE (FLAW DETECTION) WAS CARRIED OUT ON TWO SILL BEAMS -DRAW NO. JL-1190305 INSPECTION LOCATIONS**
***** NOTE: WALL THICKNESS 12mm .**

****THE ABOVE INSPECTED AREAS FOUND FREE FROM INTERNAL DEFECTS AT THE TIME OF INSPECTION**

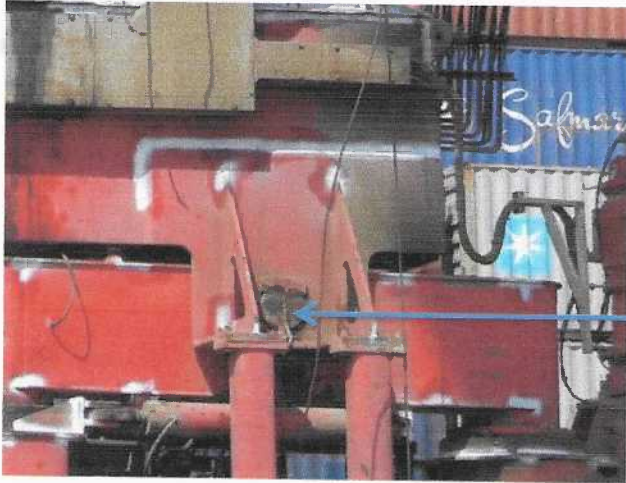
** UT . SHEAR WAVE (FLAW DETECTION) WAS CARRIED OUT ON SHAFTS OF SILL BEAMS

**THE ABOVE INSPECTED AREAS FOUND FREE FROM INTERNAL DEFECTS AT THE TIME OF INSPECTION

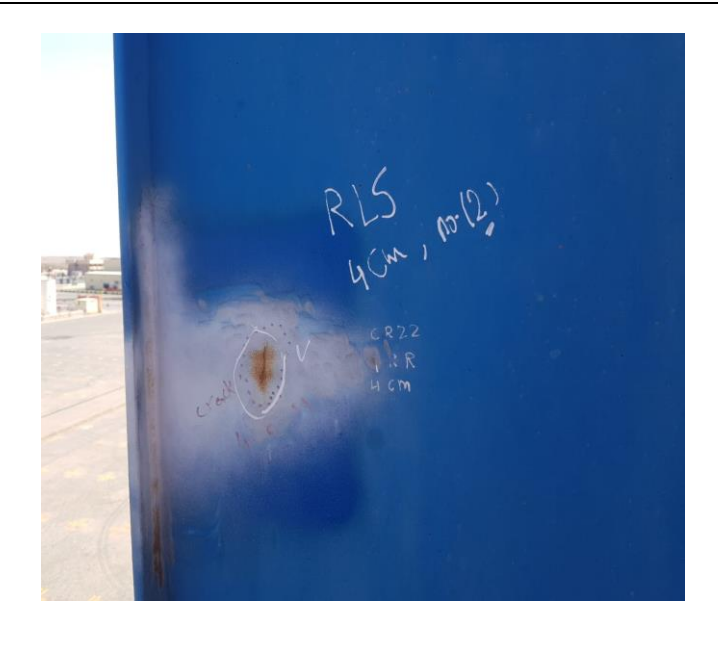
Figure No. (1)

- Right Sea Side Leg {RSS}:
 - Crack No. (1): Length: **3.0 cm**
- Right Land Side {RLS}
 - Crack No. (2): **4.0 cm**
- Left Land Side Leg {LLS}:
 - Crack No. (3): **3.0 cm**
- Left Sea Side {LSS}
 - Crack No. (4): **4.0 cm**, Crack No. (5): **2.0 cm**

Crack No.:	Length (cm)	Location	Figure No.:	CORRECTIVE ACTION
1	3.0	{RSS}	1	As per SCCT Recommendations
2	4.0	{RLS}	2	As per SCCT Recommendations
3	3.0	{LLS}	3	As per SCCT Recommendations
4	4.0	{LSS}	4	As per SCCT Recommendations
5	2.0	{LSS}	5	As per SCCT Recommendations

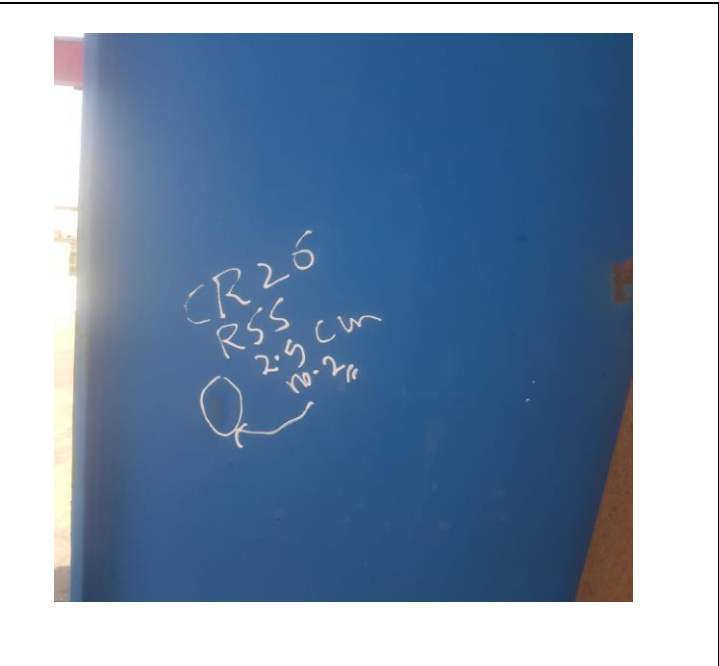
Figure No. (1)

- Right Sea Side Leg {RSS}:
 - Crack No. (1): Length: **3.0 cm**, Crack No. (2): Length: **2.5 cm**
- Right Land Side {RLS}
 - No similar Cracks found at the time of inspection.
- Left Land Side Leg {LLS}:
 - No similar Cracks found at the time of inspection.
- Left Sea Side {LSS}
 - Crack No. (3): **1.25 cm**

Crack No.:	Length (cm)	Location	Figure No.:	CORRECTIVE ACTION
1	3.0	{RSS}	1	As per SCCT Recommendations
2	2.5	{RSS}	2	As per SCCT Recommendations
3	1.25	{LSS}	3	As per SCCT Recommendations
